**Historical and visual analysis with design  
recommendations for storefronts facing the  
Madison County Courthouse square,  
Winterset, Iowa**

A Thesis Submitted to the  
Graduate Faculty in Partial Fulfillment of the  
Requirements for the Degree of  
**MASTER OF ARCHITECTURE**

1991

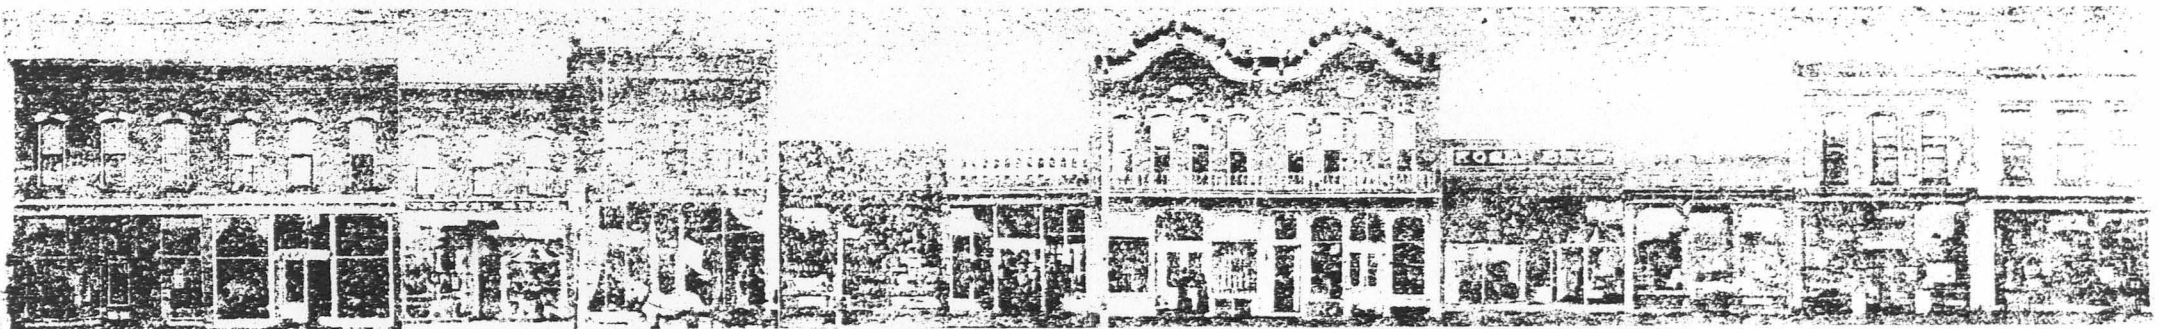
Figure 8. Photographic record of storefront elevations

Essential visual and historical information was found in a scrapbook with clippings from the December 27, 1899 "Winterset Review" newspaper (Figure 8). This year-end edition of the 50 year anniversary of Winterset contained a complete set of photographed elevations of the storefronts facing the courthouse square. These photographs made the documentation of previous existing conditions possible as it was the only source that had a complete set of storefront elevations all taken within a very narrow time frame and were referenced to a specific date.

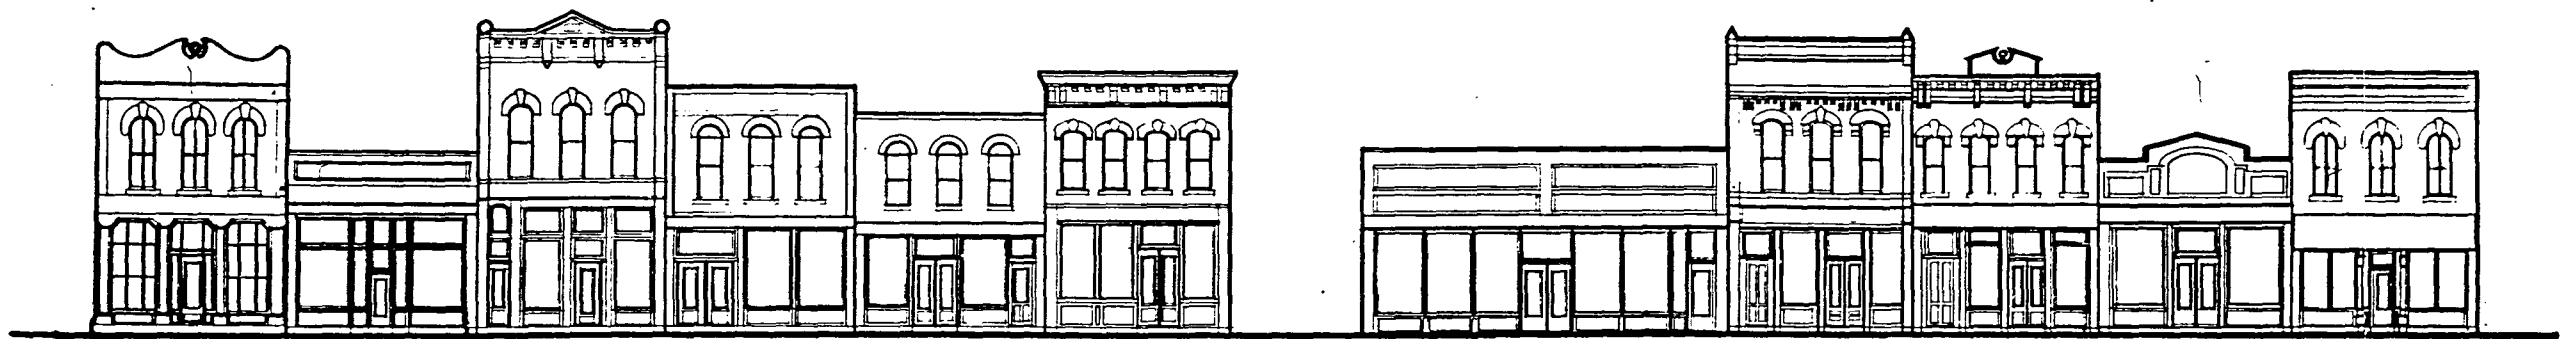
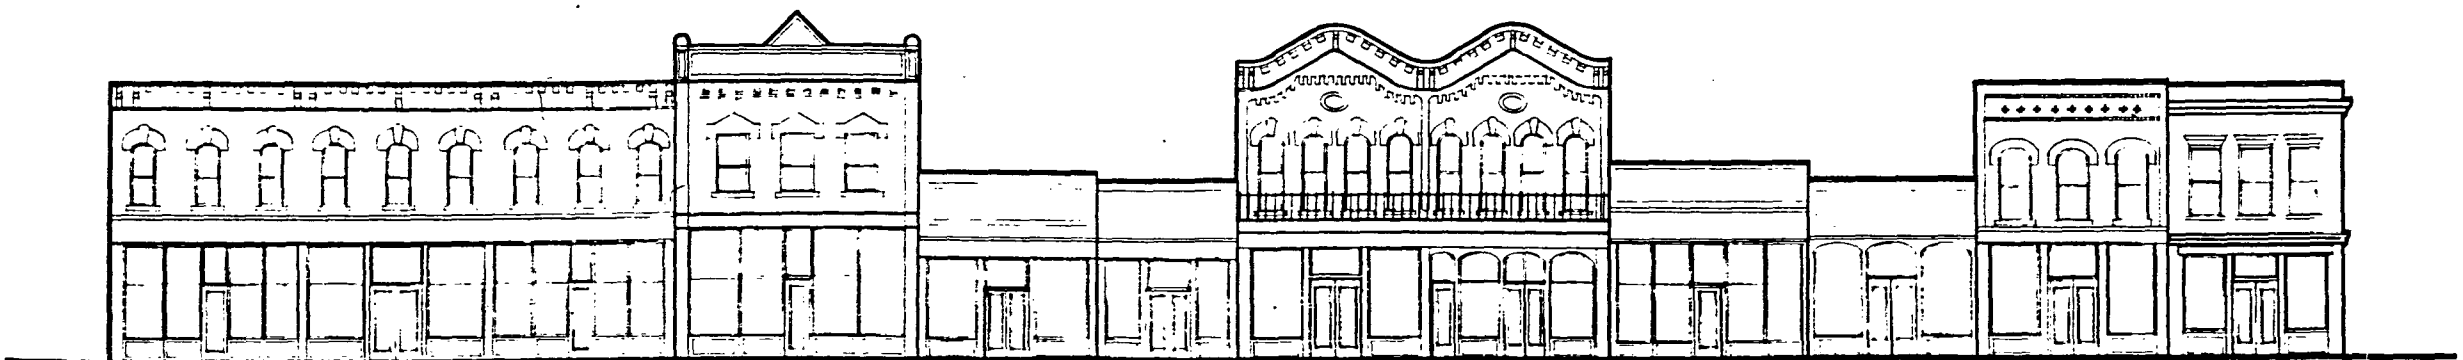
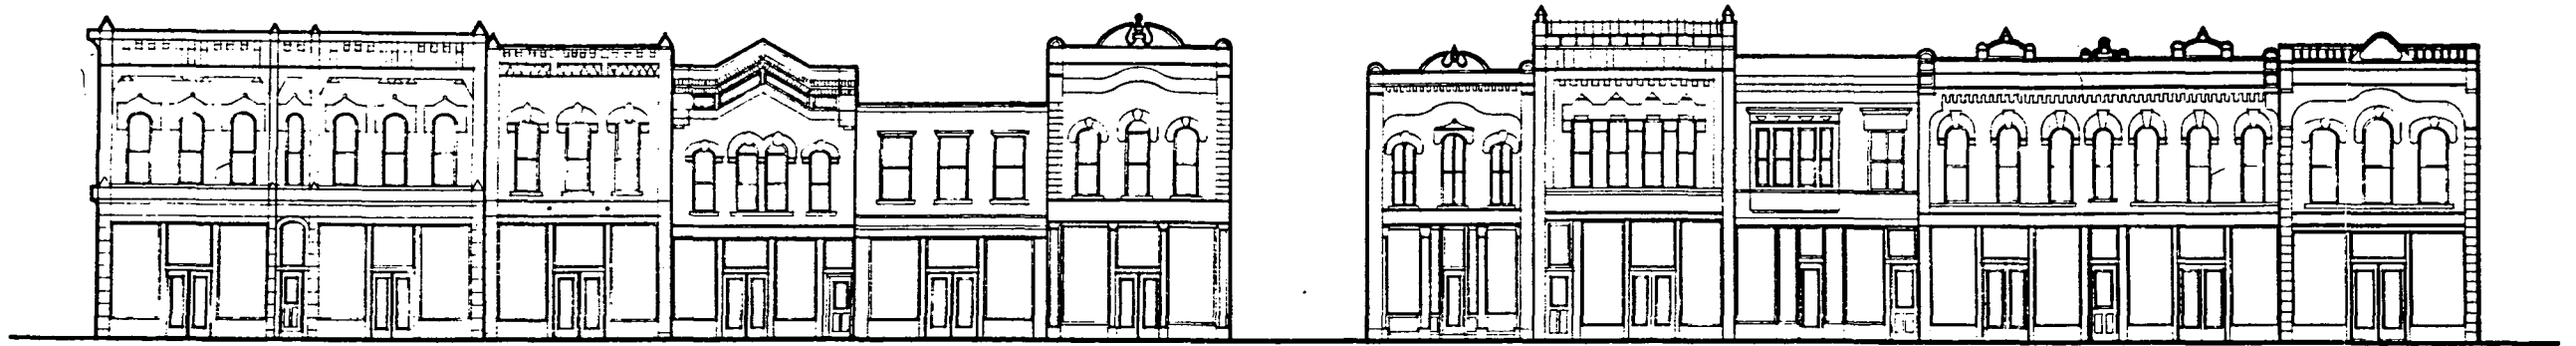
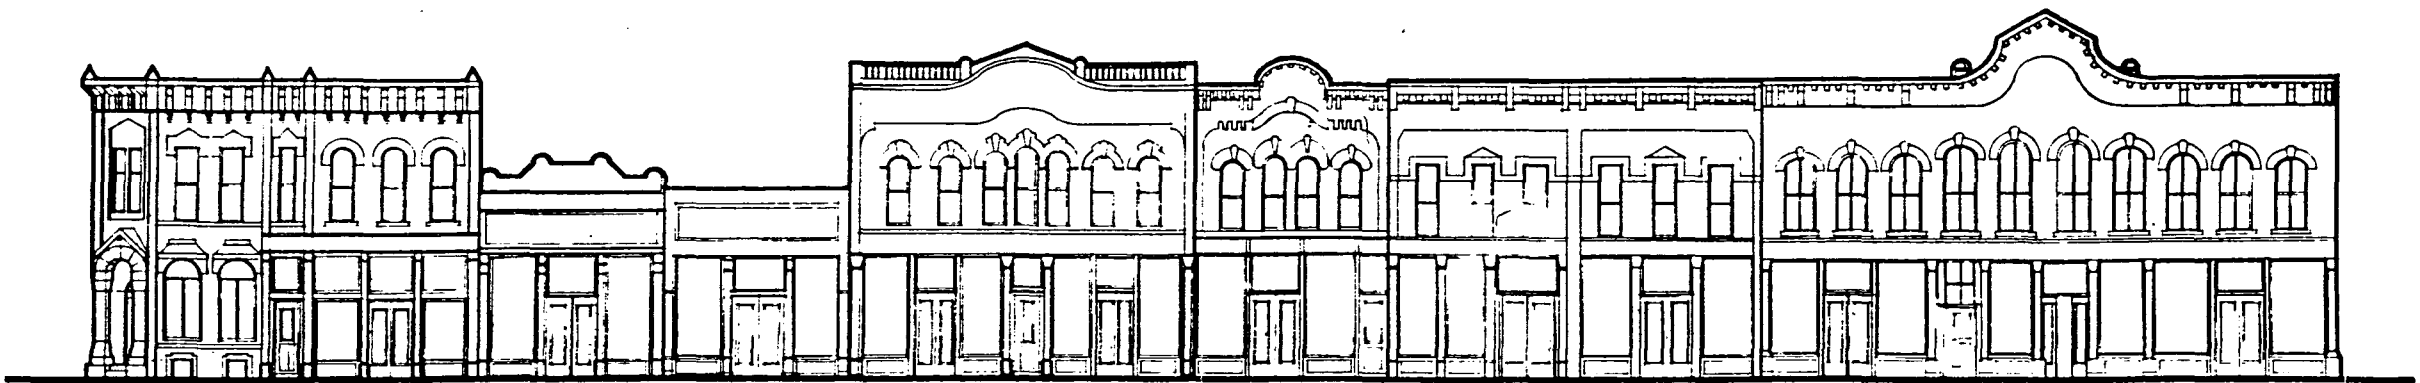
Figure 10. East elevation: historic conditions

Figure 11. South elevation: historic conditions

Figure 12. West elevation: historic conditions

Figure 13. North elevation: historic conditions

Permission to remove and photocopy the scrapbook containing the historic storefront elevations was not granted at the time, so slides of those particular pages were taken for later study. The slides were studied and elevation drawings (Figures 10-13) were generated approximating historic conditions of the 1899 storefronts. The photographs of the storefront elevations showed complete construction of all storefronts in materials, most of which exist yet today. Two major problems were encountered, however; one was the deteriorating condition of the paper on which the images were printed and the other was storefront details blocked by elements such as covered walkways and awnings casting shadows.

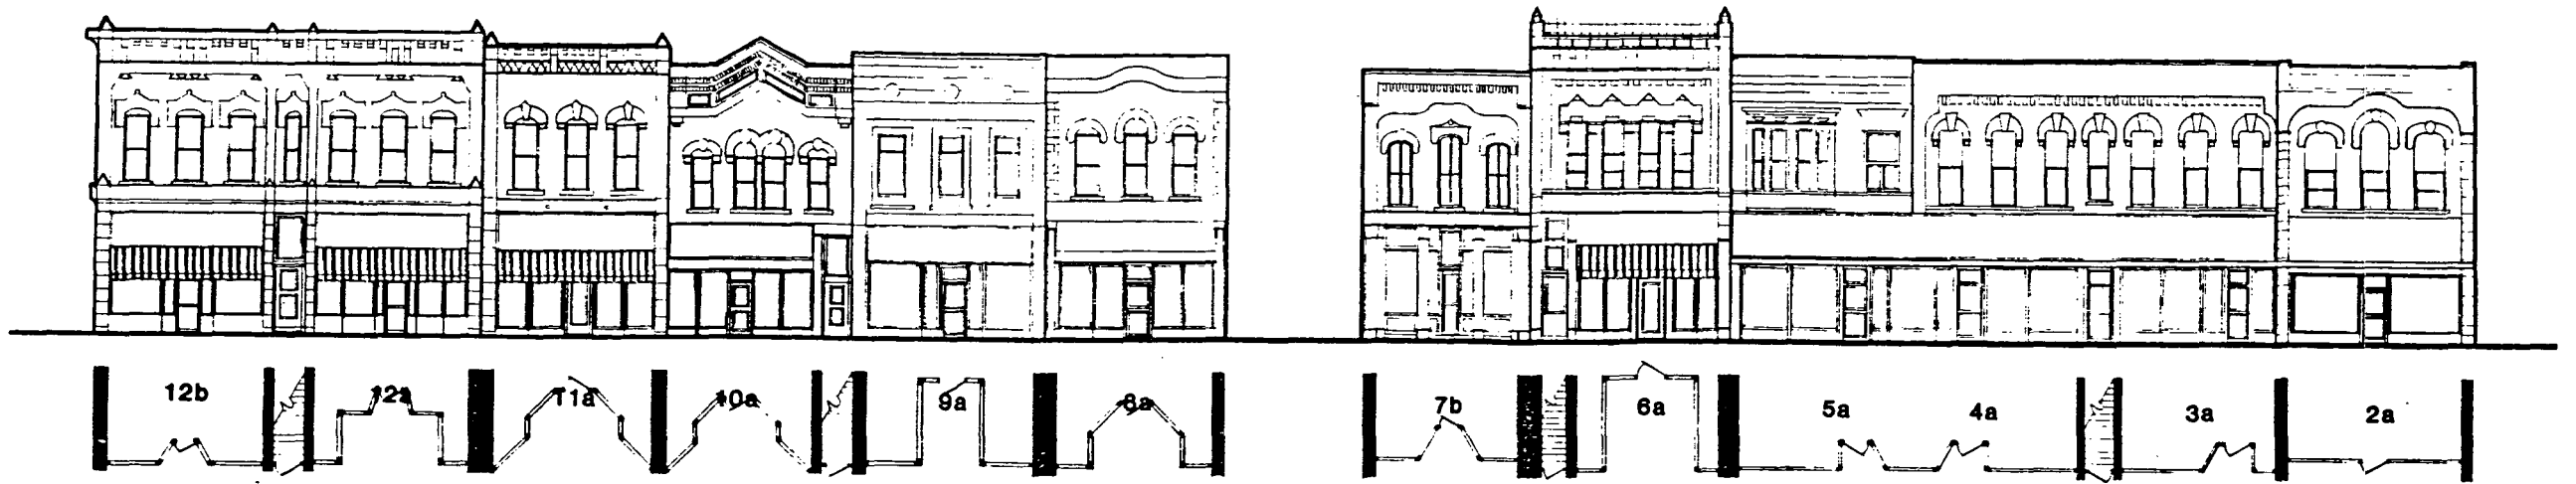
Figure 14. East elevation: existing conditions

Figure 15. South elevation: existing conditions

Figure 16. West elevation: existing conditions

Figure 17. North elevation: existing conditions

Plotted below the base elevations is a partial plan of the storefronts at street level showing articulation of major openings and structural members. The plan shows the sidewalk from the curb to 12 feet in from the major plane of the storefronts. The plan was added to clarify features on the storefronts that could not be delineated on the elevations. A tenant reference map (Figure 18) obtained from the Winterset Chamber of Commerce is included for storefront identification.

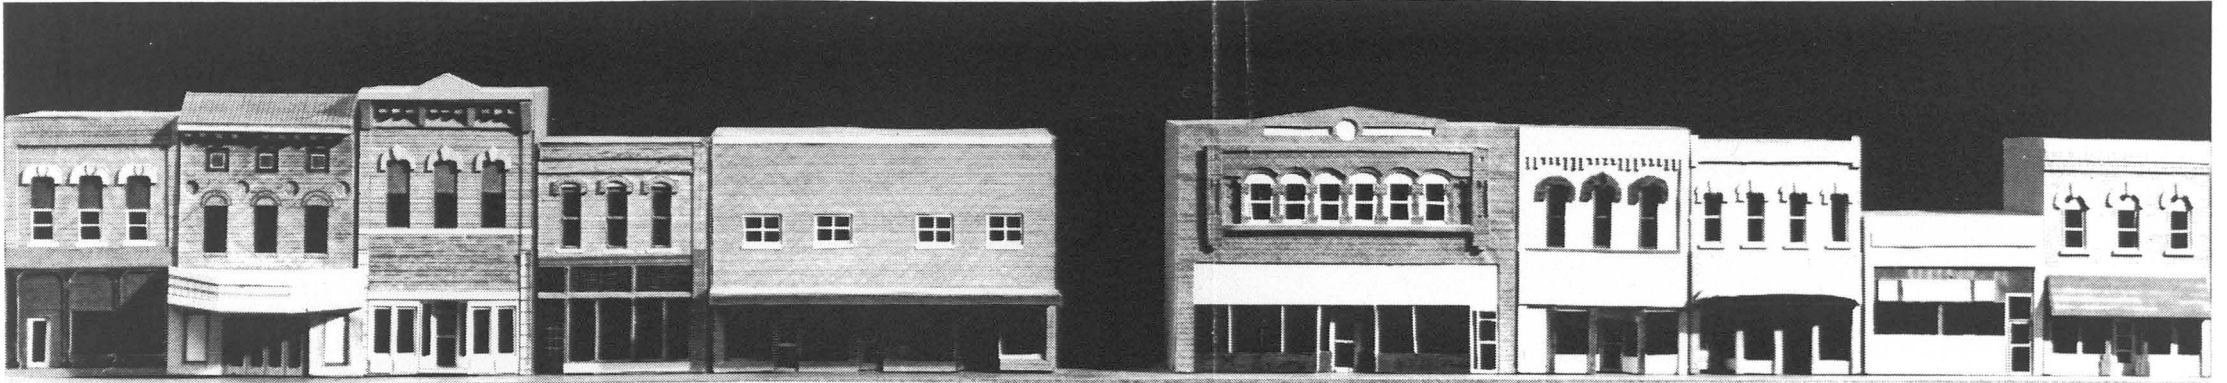
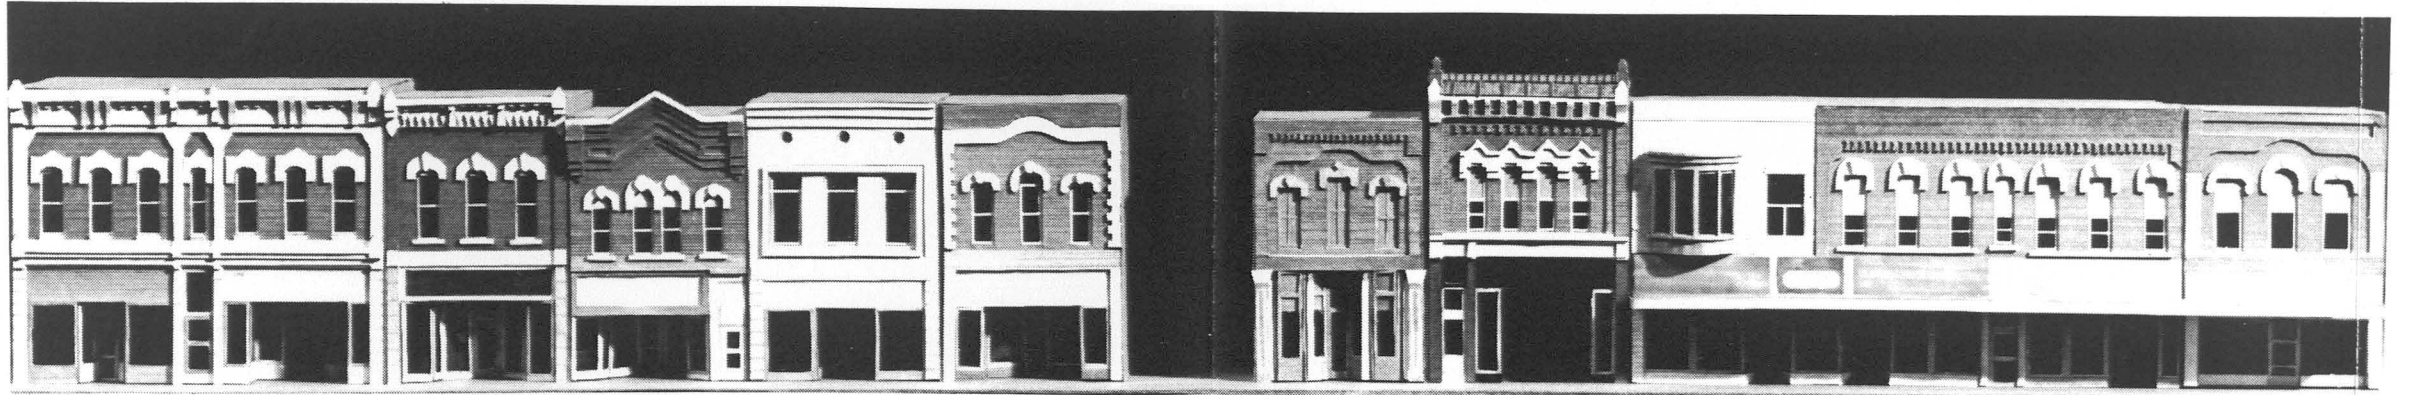
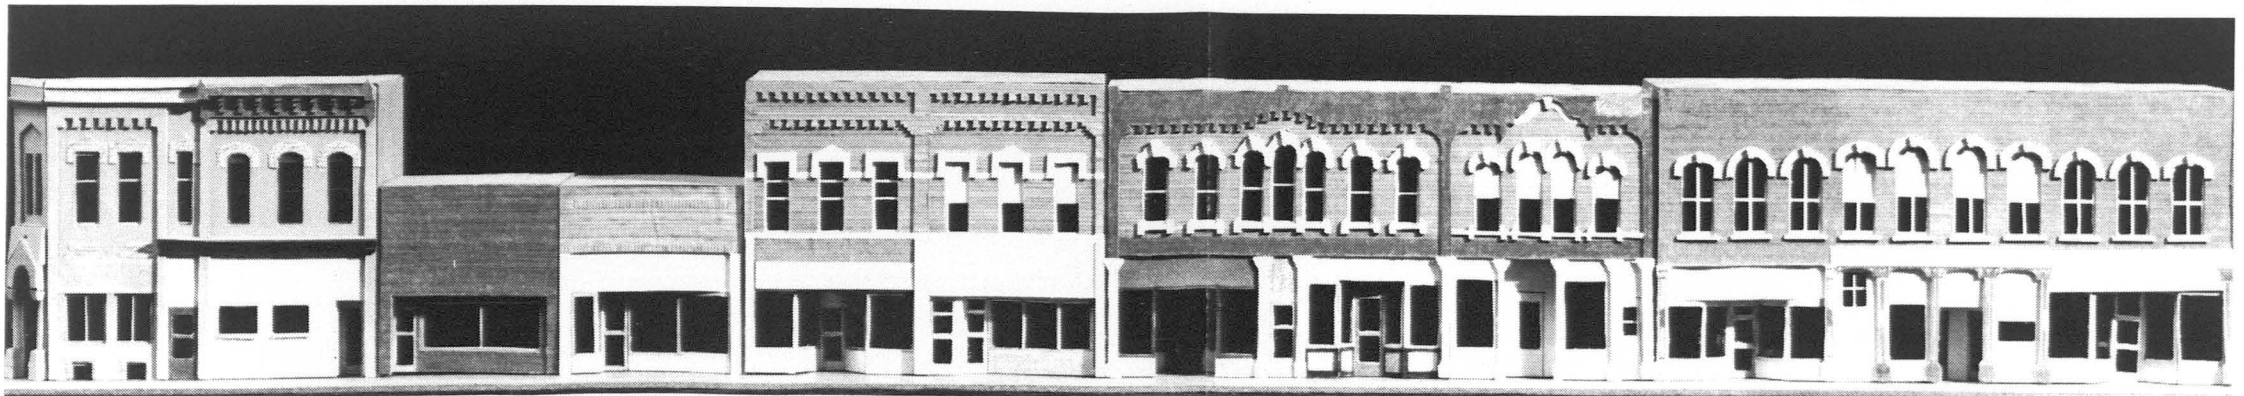
Figure 22. Model: east elevation

Figure 23. Model: south elevation

Figure 24. Model: west elevation

Figure 25. Model: north elevation

storefronts (Figures 22-25). The main objective of the models at this scale was to show form, color, and texture of the building materials and trim.

Heavy bond textured drawing paper of an appropriate color accurately represented stone. Tracings of the elevations were

applied to the paper with a non-permanent bond of adhesive as the tracing paper was to be removed after the void areas were cut out. Stone coursing was delineated in two ways: scoring mortar courses onto the paper with a dull modeling knife and drawing mortar courses onto the paper with a grey marker.

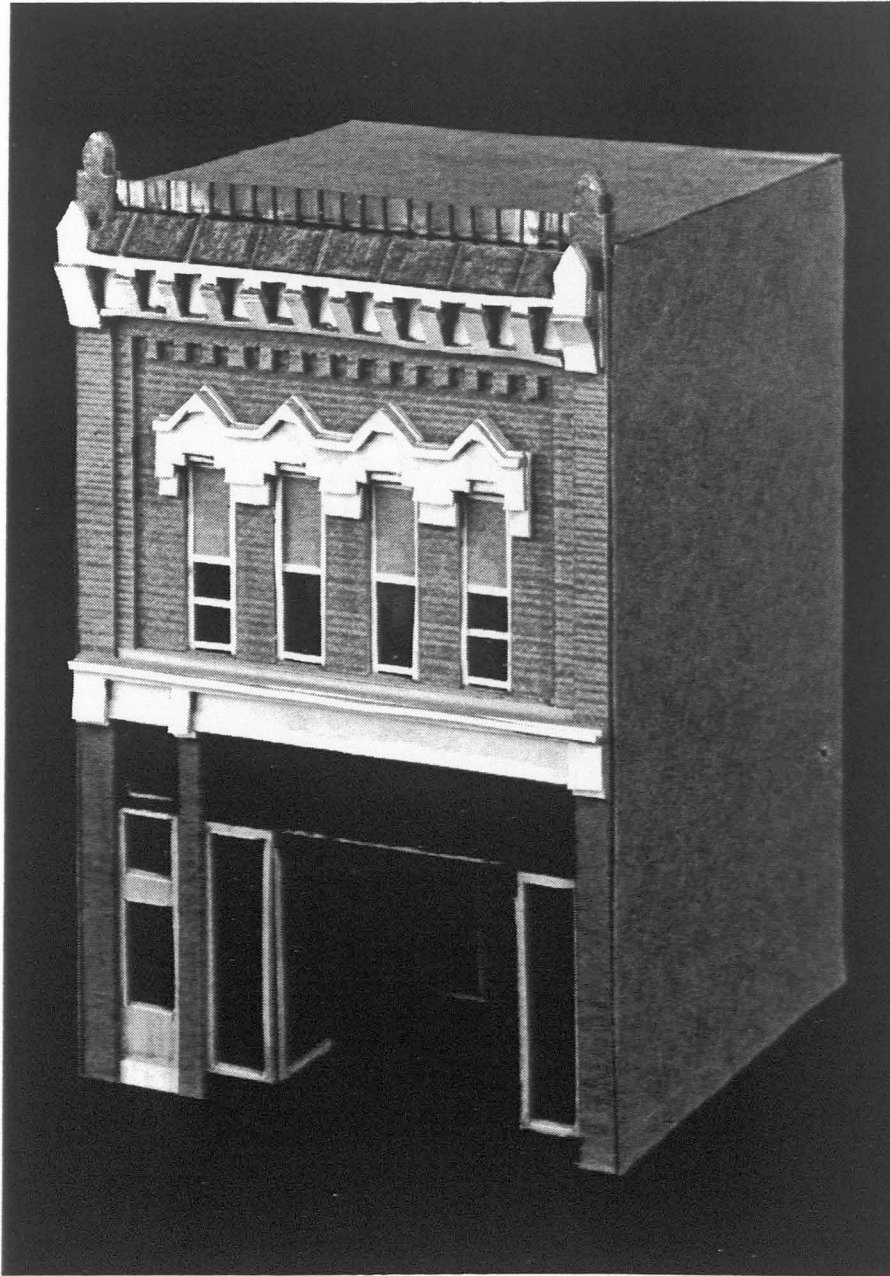
Figure 27. Detail: relief of features

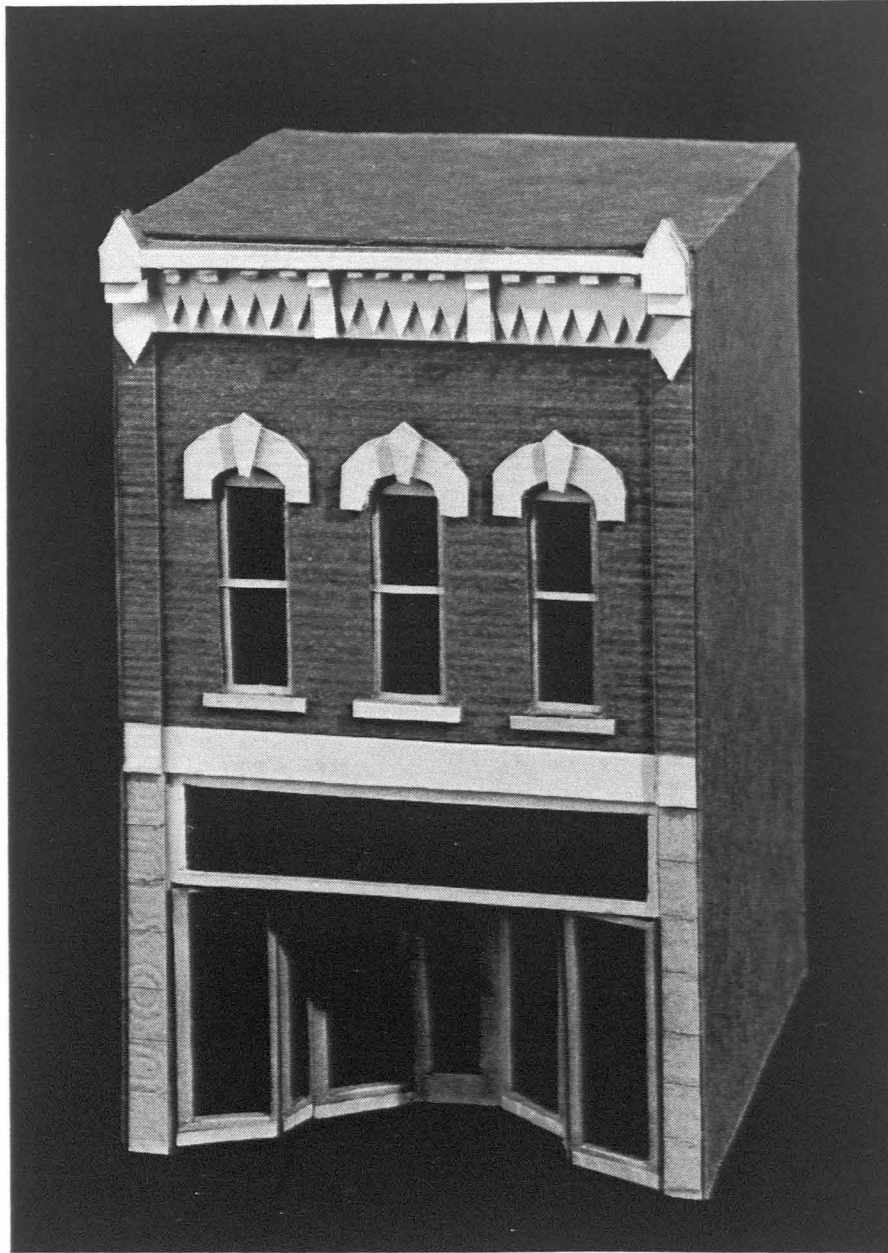
Figure 28. Detail: recessing of storefront entrances

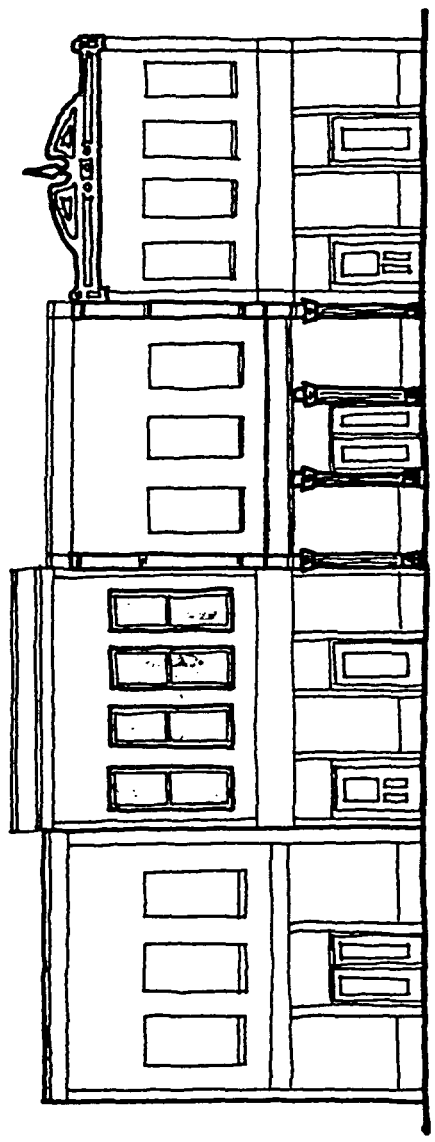
VERTICAL  
EXPRESSION

- Overall form
- Vertically oriented upper windows
- Columns and pilasters
- Pediments

Single bay facades should reinforce vertical expression

HORIZONTAL  
EXPRESSION

- Uniform cornice
- Upper story window band
- Belt courses
- Signboards/transoms
- Display windows

Figure 54. Directional expression of the facade

horizontally oriented rectangles. Figure 54 illustrates the orientation of single bay and multiple bay facades that are derived from single bay design. Certain key architectural elements, called out in the illustrations, add definition to the directional expression of a particular storefront.

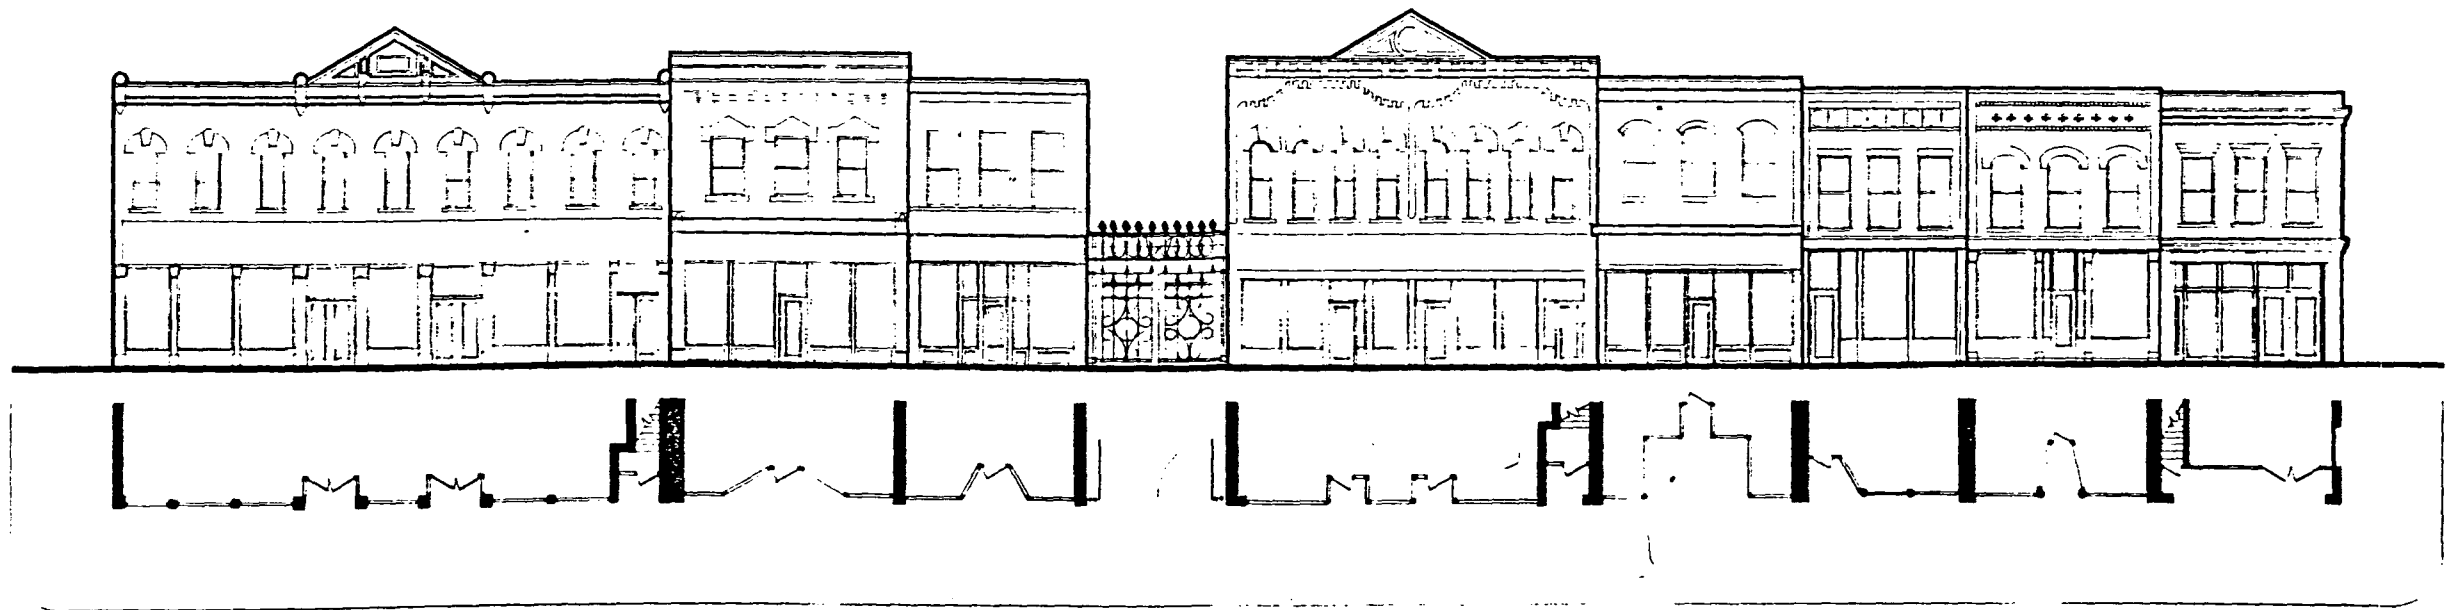
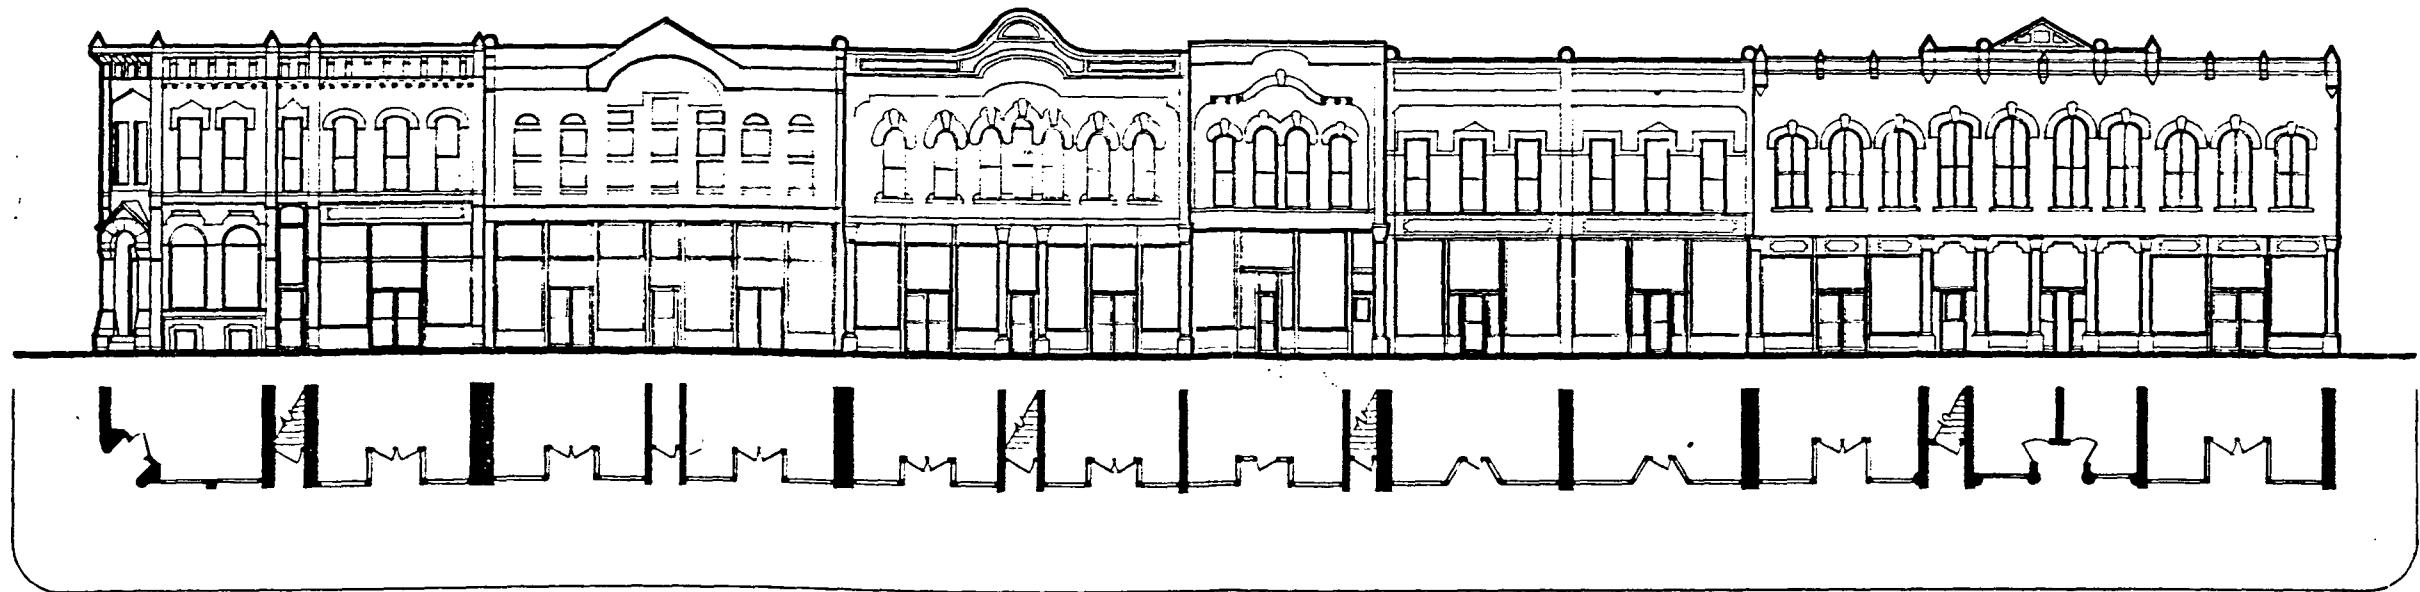
Figure 59. East elevation: recommendations applied

Figure 60. South elevation: recommendations applied

Figure 61. West elevation: recommendations applied

Figure 62. North elevation: recommendations applied

None of these new elevation drawings indicated any approach following the strict definition of preservation. This is largely a result from combining interpretation of the composite elevation drawings and first-hand inspection of existing conditions. While overall visual image characteristics (proportions, rhythms, and directional
