Preservation and the ADA:
Adapting the historic building for accessibility

A Thesis Submitted to the
Graduate Faculty in Partial Fulfillment of the
Requirements for the Degree of
MASTER OF ARCHITECTURE

Iowa State University
Ames, Iowa

1994

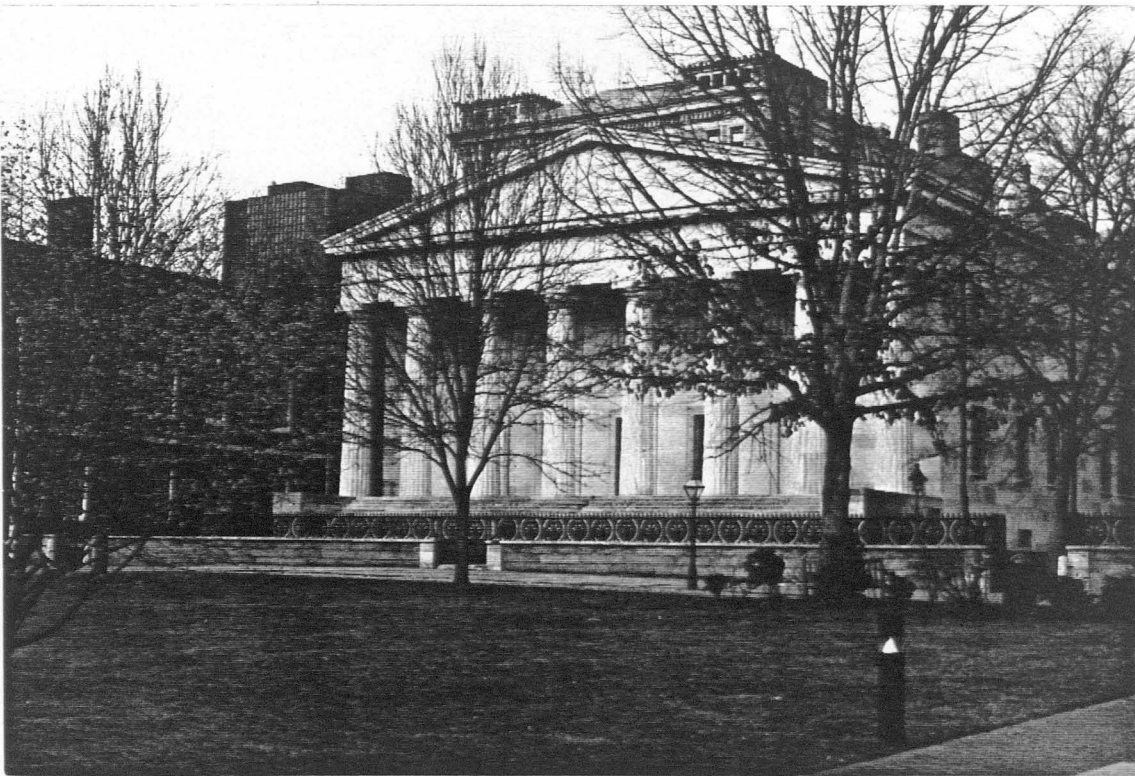
Figure 1. South view of the Second Bank of the United States

The Second Bank (Figure 1) was founded in 1816. Nicholas Biddle, its influential president, was a Champion of Greek architecture. When the bank held a competition for the design of the new building, he required all the architects to use the Greek style. Strickland's design is one of the first Greek Revival buildings in the country. Modeled on the Parthenon, it features plain Doric columns and little ornamentation except for the triglyphs and metopes on the entablature. It appears to be built of solid

Preservation has clearly been the priority in making this building accessible. It is only through the use of apparatus that many disabled visitors are able to get inside the building. While there are no readily apparent answers to the accessibility problems faced by the Second Bank, the creation of a second primary entrance at grade on the buildings side could offer a more desirable experience of entrance to people with

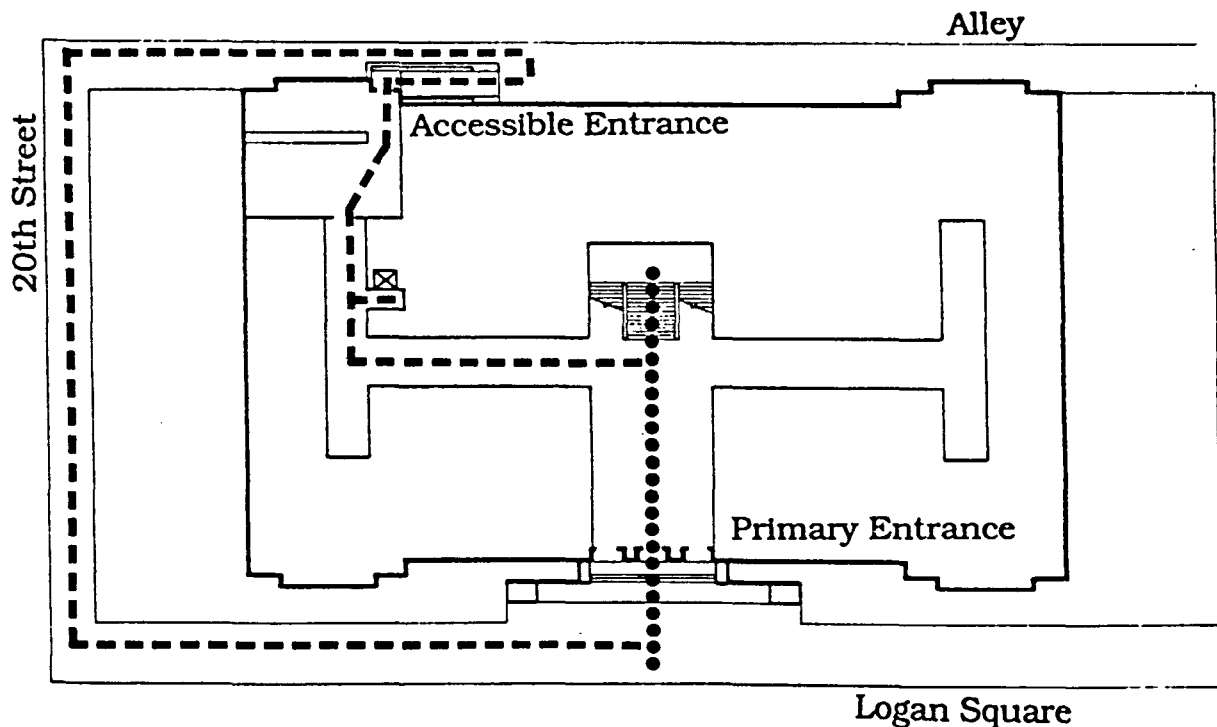
Figure 2. Plan of Free Library of Philadelphia

to reach the main circulation areas or the elevators. Very little modification was required to accomplish this, but it is by no means an appropriate solution. What is achieved here is a very minimal form of accessibility. There is no equality of experience, and it is a very secondary entrance that is provided.

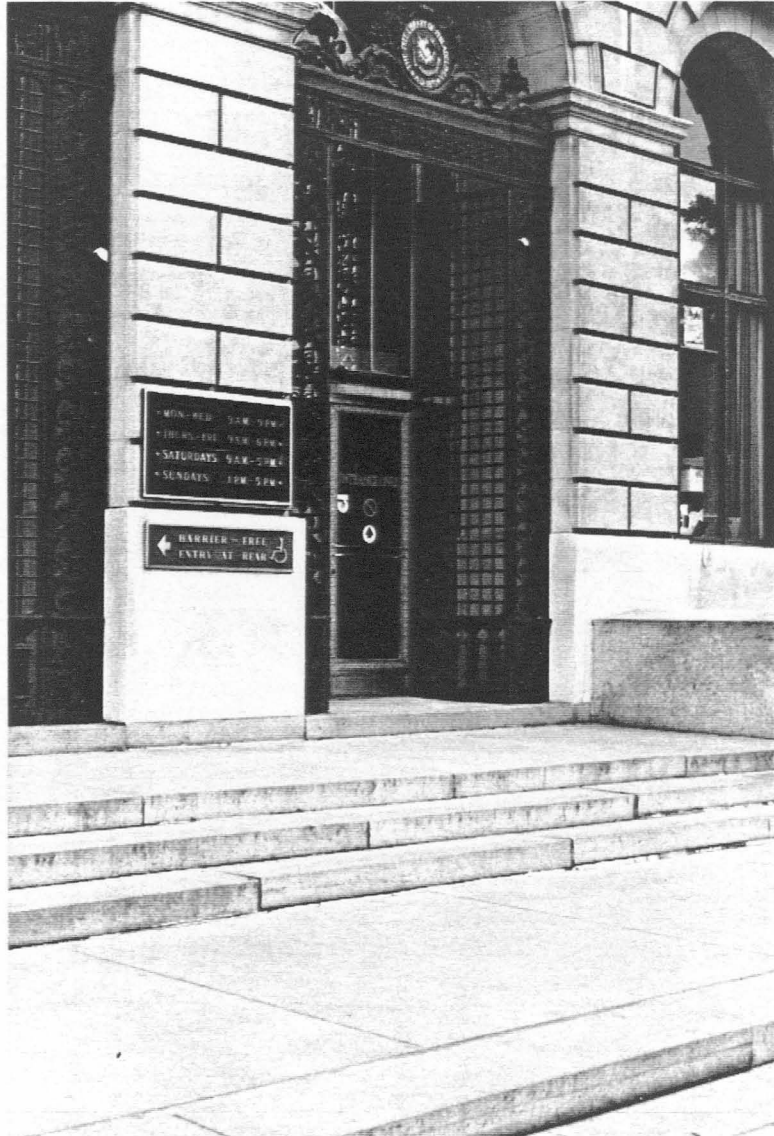
Access is achieved at the primary entrance by climbing a number of stairs at the center of the Logan Square side of the building (Figure 2, 3). Due to the nature of the building type and the requirement for controlled access, this is the only public entrance to the library. It is not barrier-free. The library's barrier-free entrance (Figure 4) is located at the rear of the building, off a narrow alley that also serves the loading docks and garbage dumpsters, and is also home to members of Philadelphia's homeless community. A ramp leads down from street grade to the main level of the building. One enters the library through a storage room behind the reference desk. People with disabilities must then follow a circuitous route

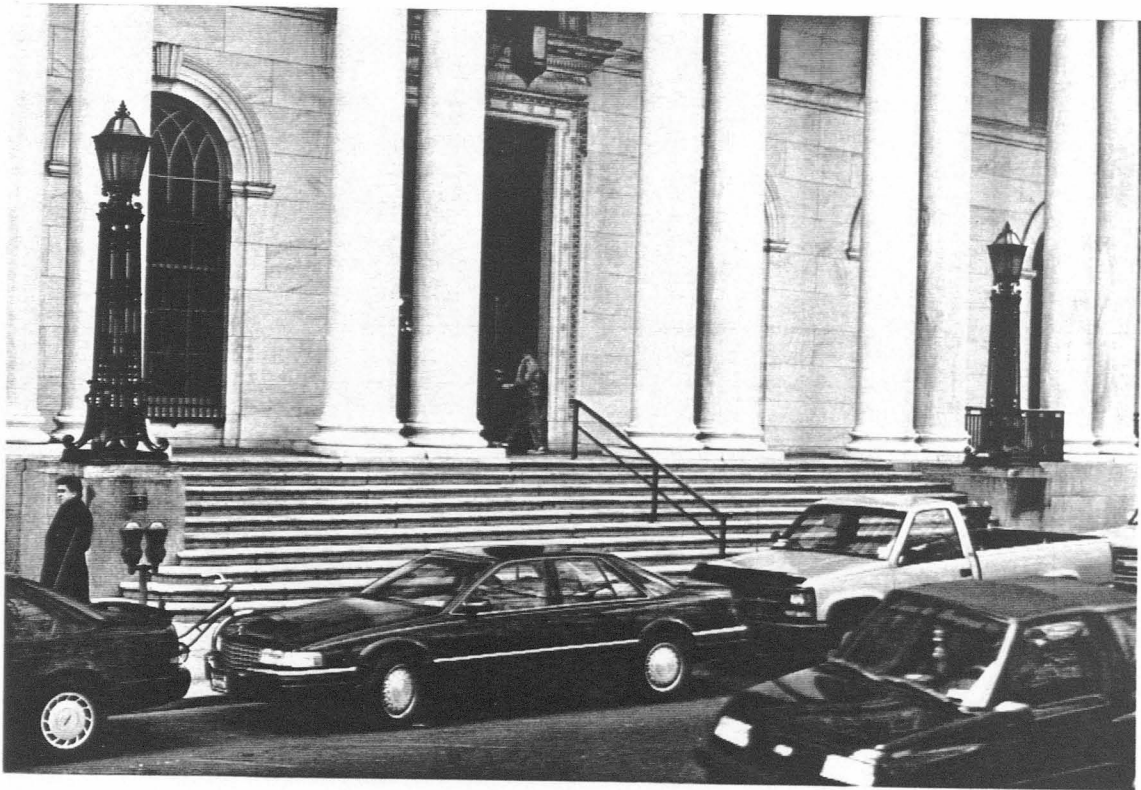
Figure 6. The Curtis Center, main entrance

The building's main entrance (Figure 6) is located on 6th Street, facing Independence Square, and was not modified for accessibility, and the original procession of entrance has been preserved. Rather, the old loading docks on the Washington Square side of the building were rehabilitated as a new primary entrance (Figure 7). An interior ramp leads from the street level up into the interior of the building. While the new entrance does not lead into the lobby, as does the original entrance, it is equally proximate to the elevators and retail spaces, and leads directly into the atrium. The use of this building has changed, and the atrium, now the principal interior space in the building, is often the main destination of many of the buildings users.

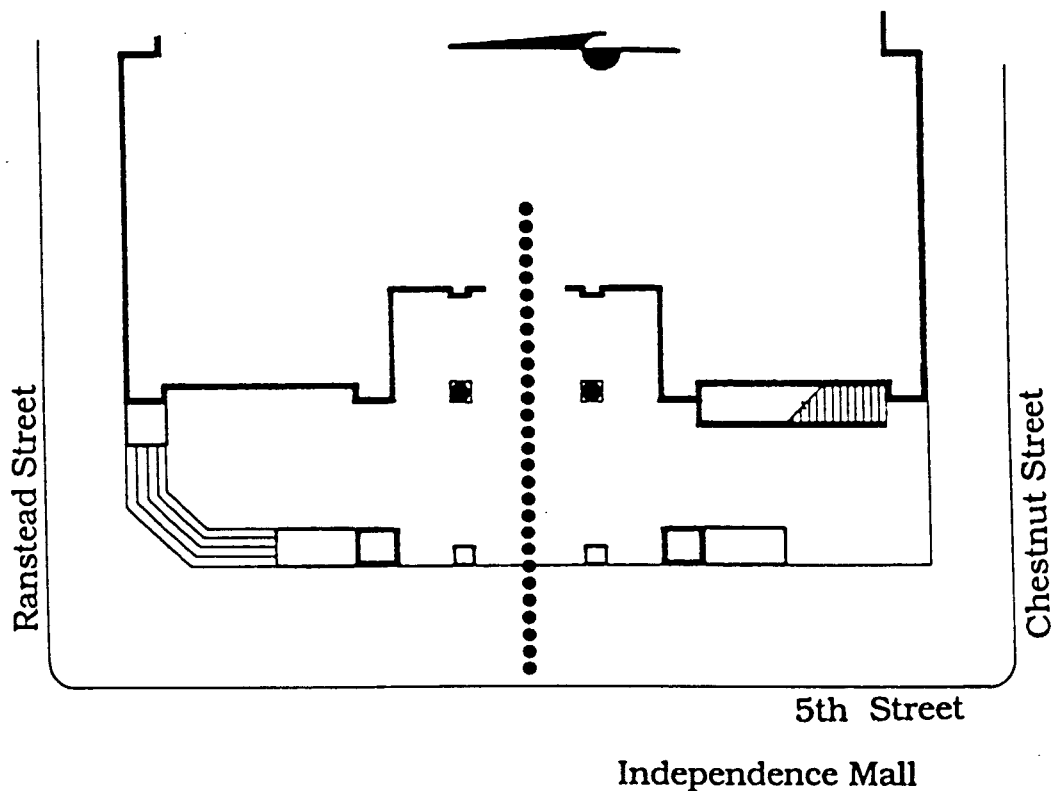
Figure 12. Plan of the Bourse

The Bourse was the one case found where the primary entrance has been successfully made accessible (Figure 12). It is possible, however, that the site offered some opportunities. Stairs were removed and the entry regraded to take advantage of the sloping site. A level plaza was created at the main entrance: it meets the street at grade at the south end of the site (Figure 13), is slightly ramped at the center (Figure 14), and is accessible by stairs at the north end (Figure 15). In this case, the character of the building and the sense of entry are preserved. Accessibility is provided for everyone, and the shared experience of entering the building is undiminished.

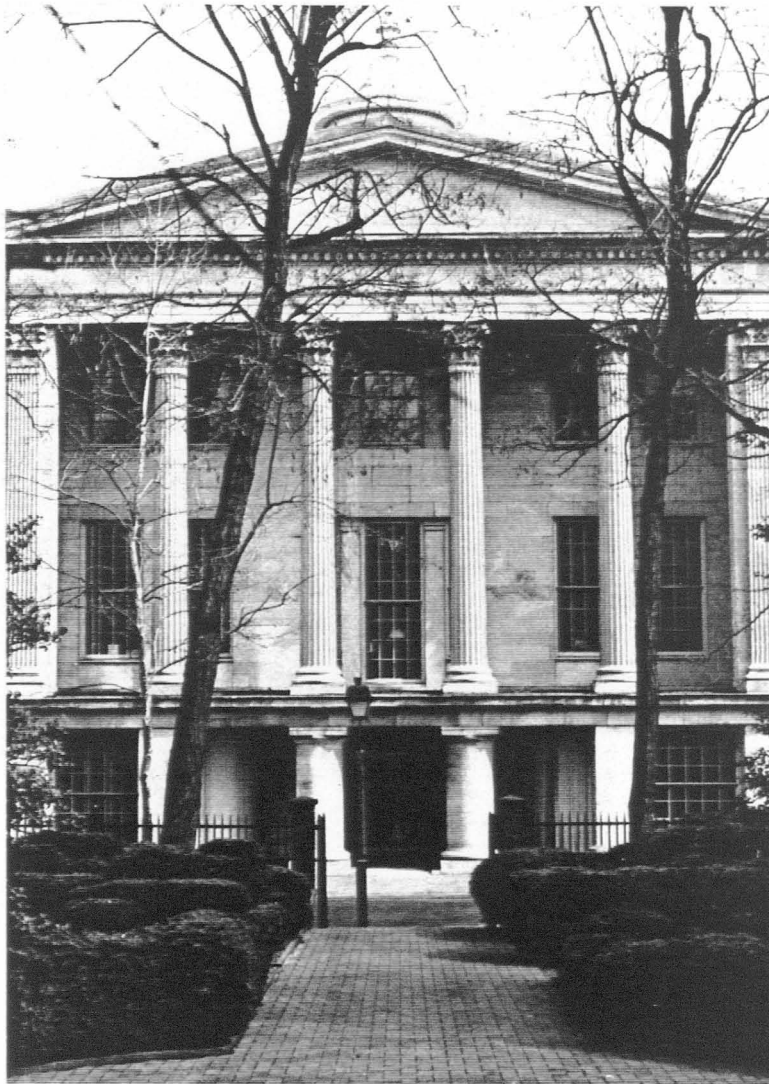
Figure 16. Entrance to Merchants Exchange

Since there is only a single step at the main entrance, accessibility has been achieved by carving a curb cut into the central bay, and installing an automatic door (Figure 17). This allows anyone to use the primary entrance, the only public entrance to the building. The use of the curb cut in the single step destroys little historic material, preserves the character of the entrance, and greatly improves accessibility. Thus everyone is able to share the same route and the same experience of entry.

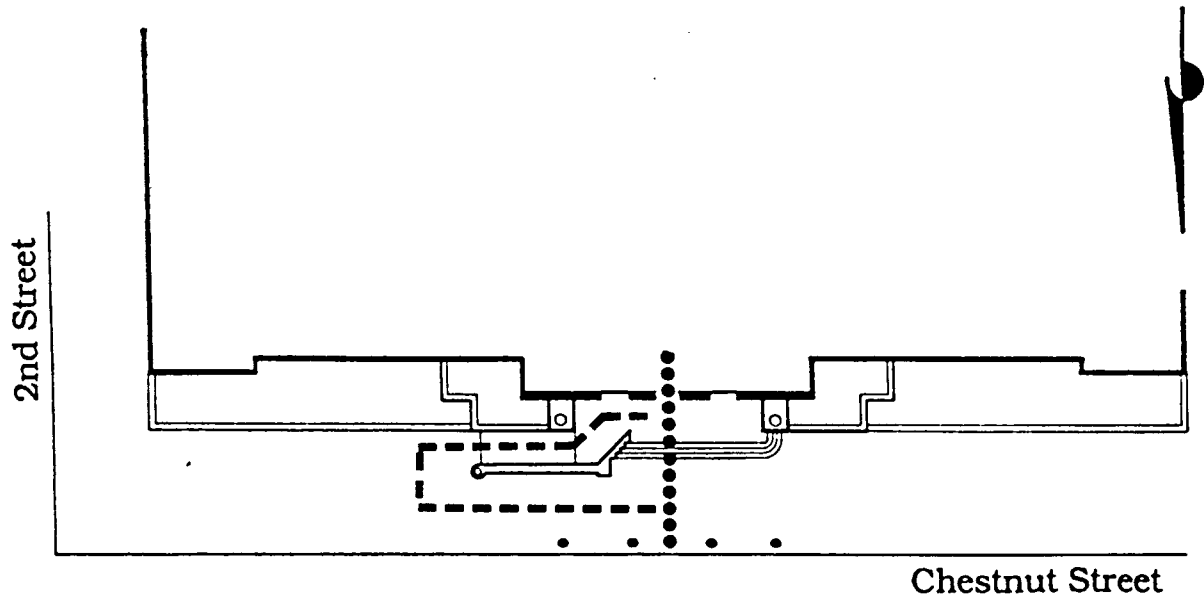
Figure 18. Plan of United States Customs House

The U. S. Customs House (Figure 18) was built to replace the Second Bank of the United States building, which had housed the Customs offices since 1844. The increased traffic in the Port of Philadelphia and the need for other Federal office space required a much larger building. A beaux-arts structure of brick and granite, the building is entered through three arched doorways at the center of the block. They are reached after mounting four steps from the street grade (Figure 19).

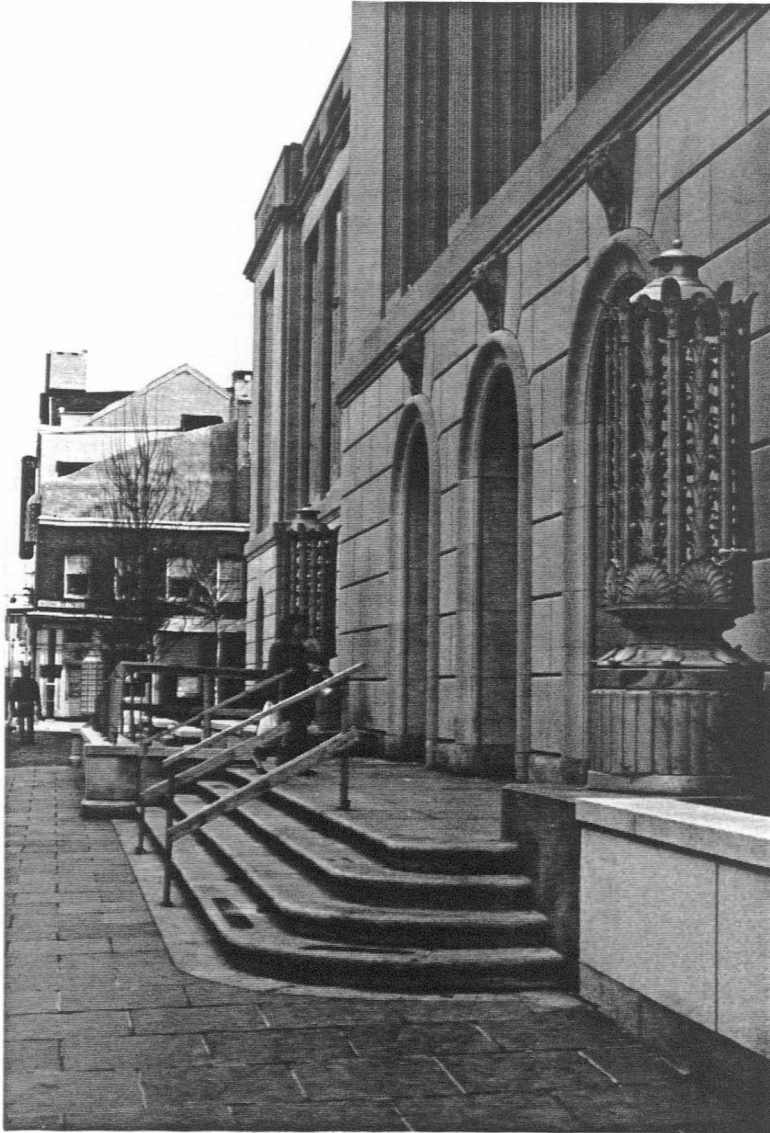
Figure 19. West approach to U. S. Customs House

During a major restoration of the building completed by the Federal Government in 1993, a ramp was added at the primary entrance to allow access for people with disabilities (Figure 20). While the addition of a ramp at the primary entrance can often compromise the character of a historic building, in this case, the design shows sensitivity to the goals of both accessibility and preservation. It is clearly an addition to the building, but it uses compatible materials and is respectful of the historic fabric of the building. It gives a primary, shared entrance to the building, without interrupting existing traffic patterns.

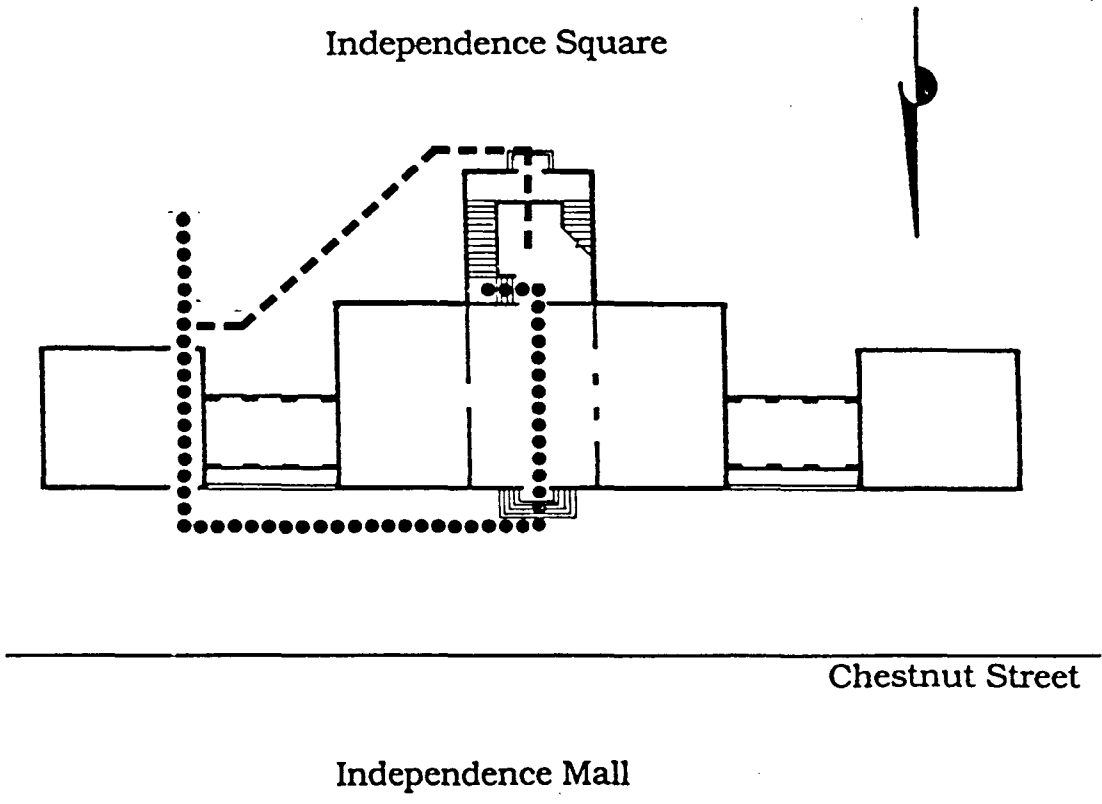
Figure 21. Plan of Independence Hall

Access to Independence Hall is limited to the guided tour (Figure 21), which takes visitors into the rear entrance of one of the side buildings, out the front, and into the front entrance of the main building (Figure 22). People with disabilities who cannot use the stairs, however, are taken back out the rear entrance, and then in the rear entrance of the main block (Figure 23). While it is unfortunate that there must be a separate experience of entry for people with differing abilities, the symbolism of Independence Hall precludes almost any alteration.

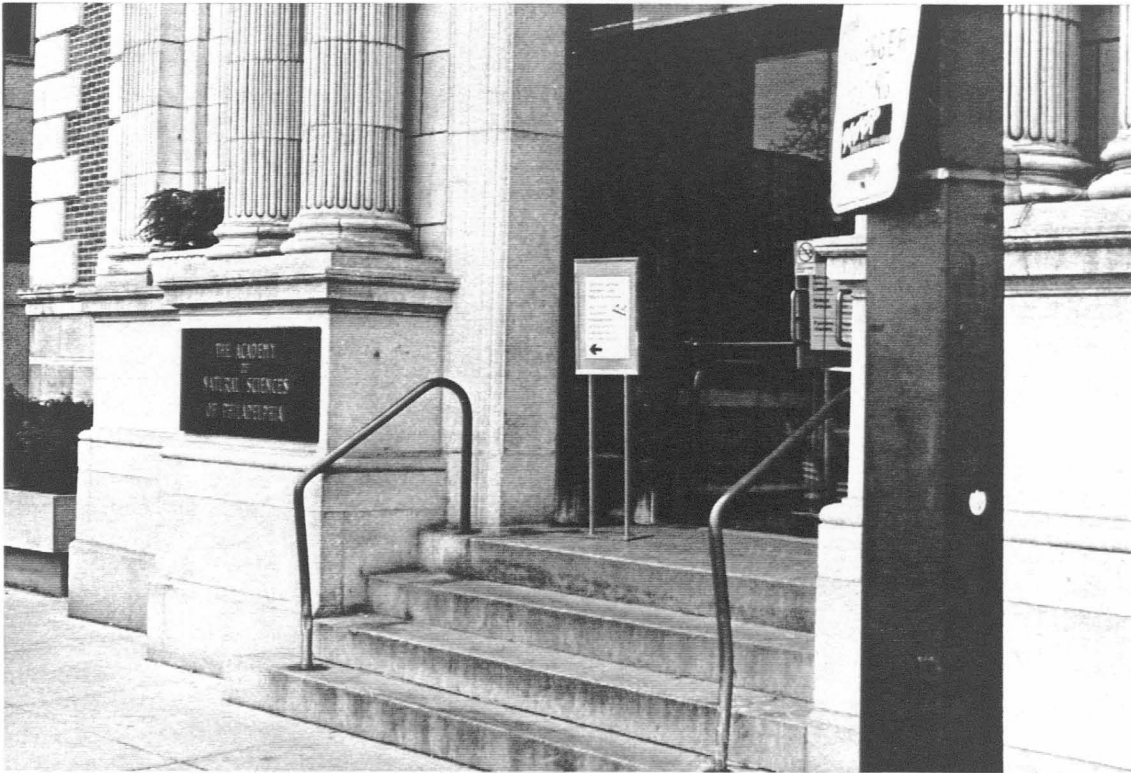
Figure 25. North (main) entrance to Academy of Natural Sciences

The main entrance (Figure 25) is unpretentious, yet it makes its presence known on the Square. There are a number of steps that prevent the disabled visitor from using this entrance. The group entrance (Figure 26), located on 19th Street, is at street level and is barrier-free. While there is little difference in scale or style between the two entrances, the group entrance does not feel as important. It is off the beaten path, and not proximate to Logan Square, an important landmark. Once inside the building, people often find the route to the main areas confused. While the group entrance provides a secondary experience of entry, it is not so clearly "second rate" as the Free Library, for example.

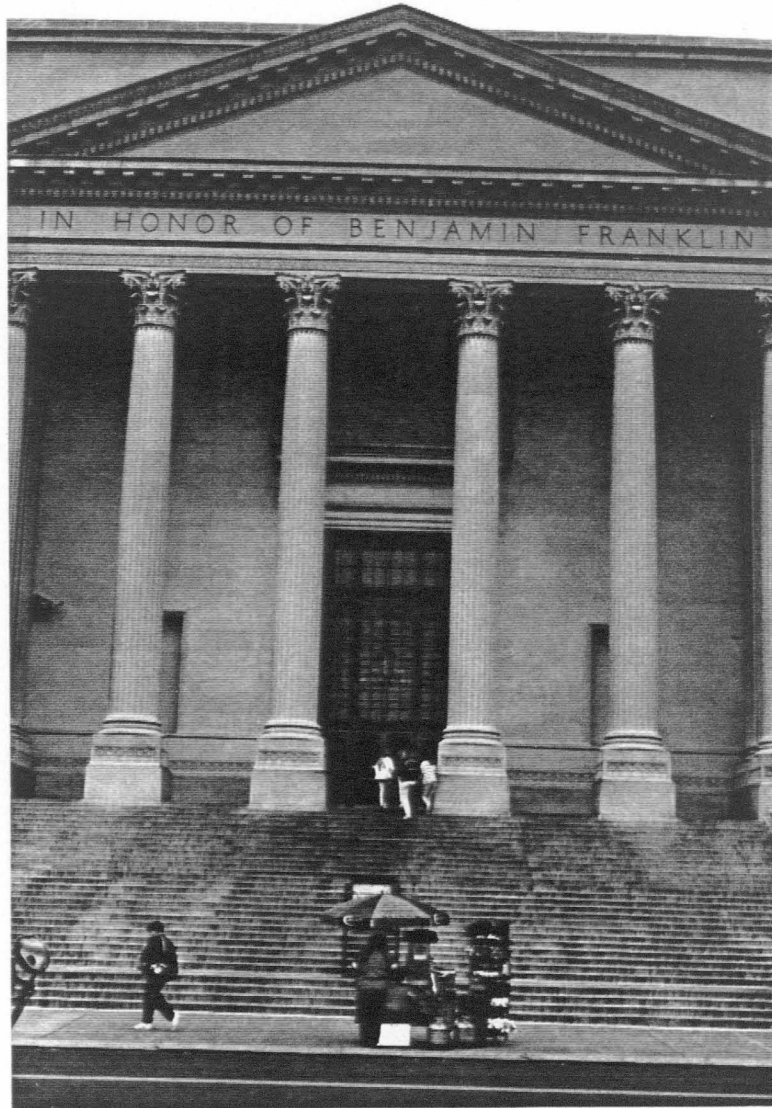
Figure 28. East (main) entrance to the Franklin Institute

Access to the memorial, and the museum spaces, is by way of a monumental stair on the Logan Square side of the building (Figure 28). People with disabilities must use a ramp to enter the staff entrance (Figure 29) on the northern side. While the barrier-free entrance is on a primary side of the building, facing the Parkway, it remains a secondary entrance. The ramp itself diminishes the experience of the person who uses it, and detracts from the character of the building. The barrier-free entrance does not address the important interior spaces. From the staff entrance, people with physical disabilities must follow a long, circuitous, and complicated path to reach the elevators and the main public spaces upstairs.

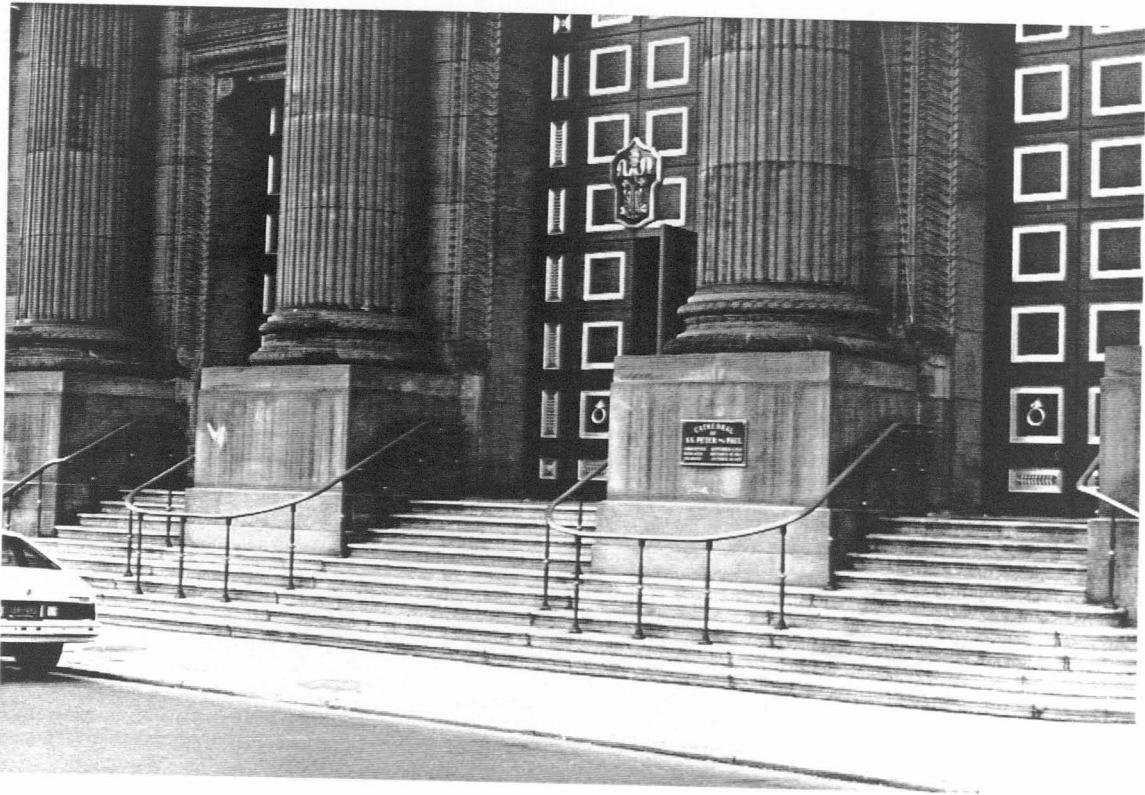
Figure 31. West (main) entrance to Cathedral of Saints Peter and Paul

The primary entrance (Figure 31) is at the west end of the church and faces Logan Circle, and is inaccessible due to a series of stairs. The creation of an accessible entrance was recently achieved by adding a ramp at the transept entrance (Figure 32). Here again is a situation in which the secondary entrance, while somewhat accommodating, does not offer the same quality of experience as does the main entrance.

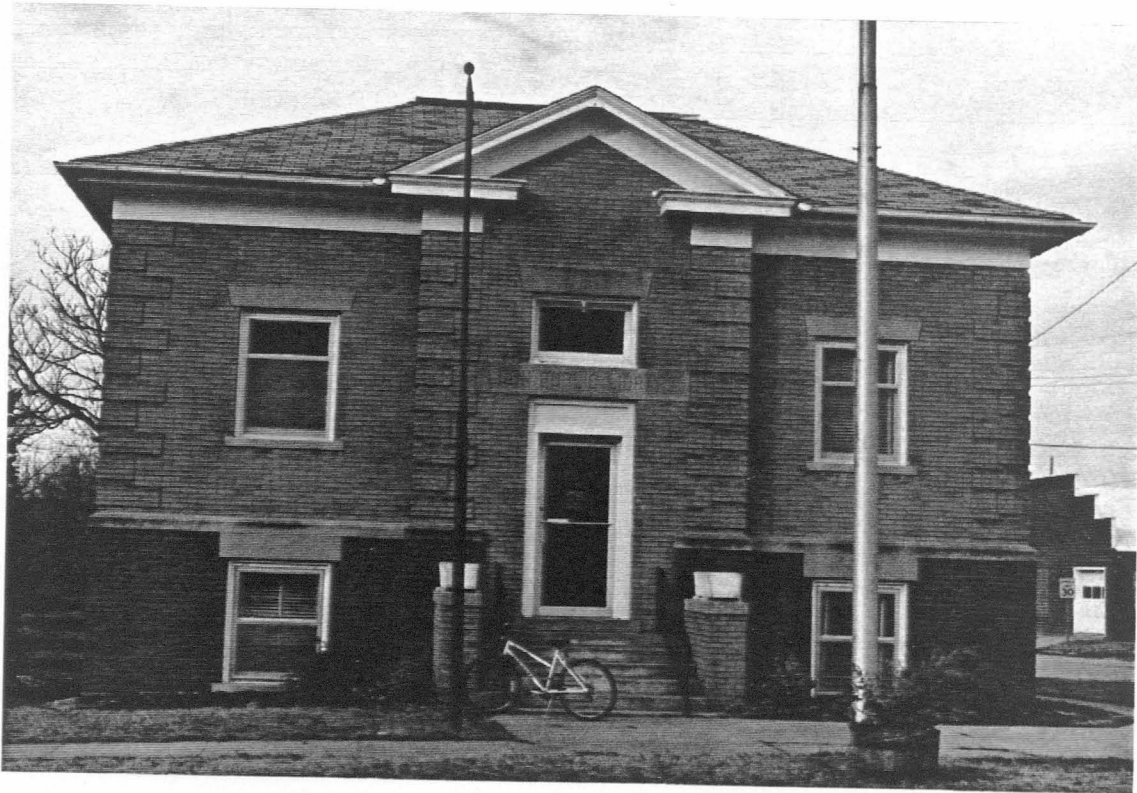
Figure 34. South view of Leon Public Library

Entrance to the building is possible through the primary entrance at the front of the building,(Figure 34) or by a secondary entrance at the rear of the building (Figure 36), near the parking lot. The primary entrance is typical of Carnegie libraries: half a flight of steps to the door, and then another half a flight up to the main floor, or down to the children's library. The secondary entrance is also inaccessible: down several steps, and through a storage/workroom and into the children's library. This was never

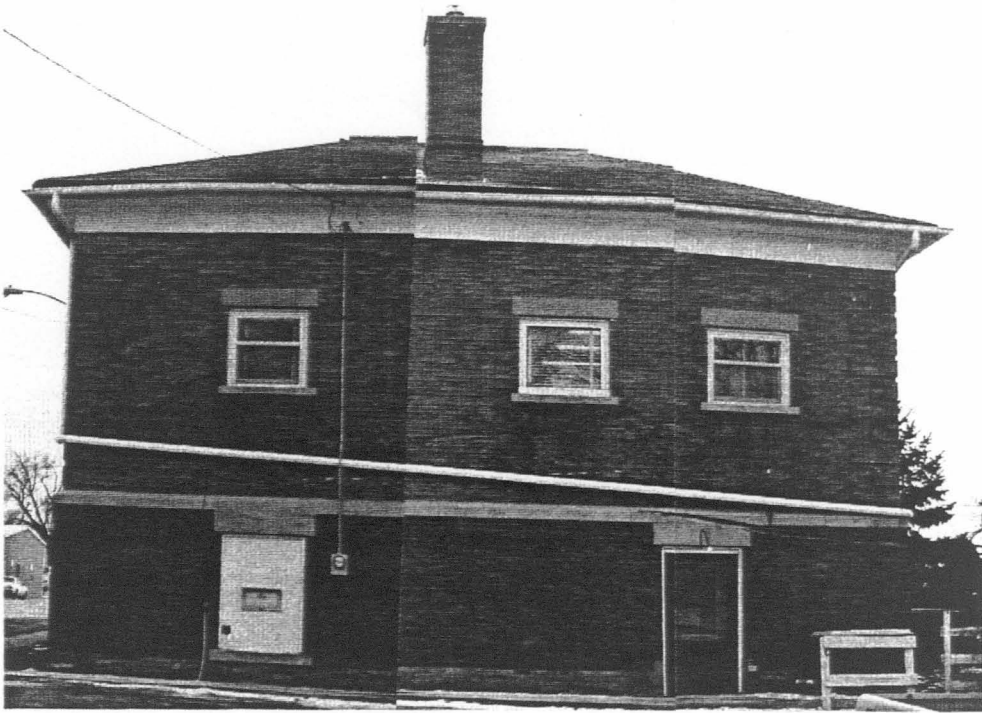
Figure 36. North view of Leon Public Library

meant to be used as a public entrance, but over the years, it has been used because of its proximity to parking, and the lack of a need for control over access to the library.

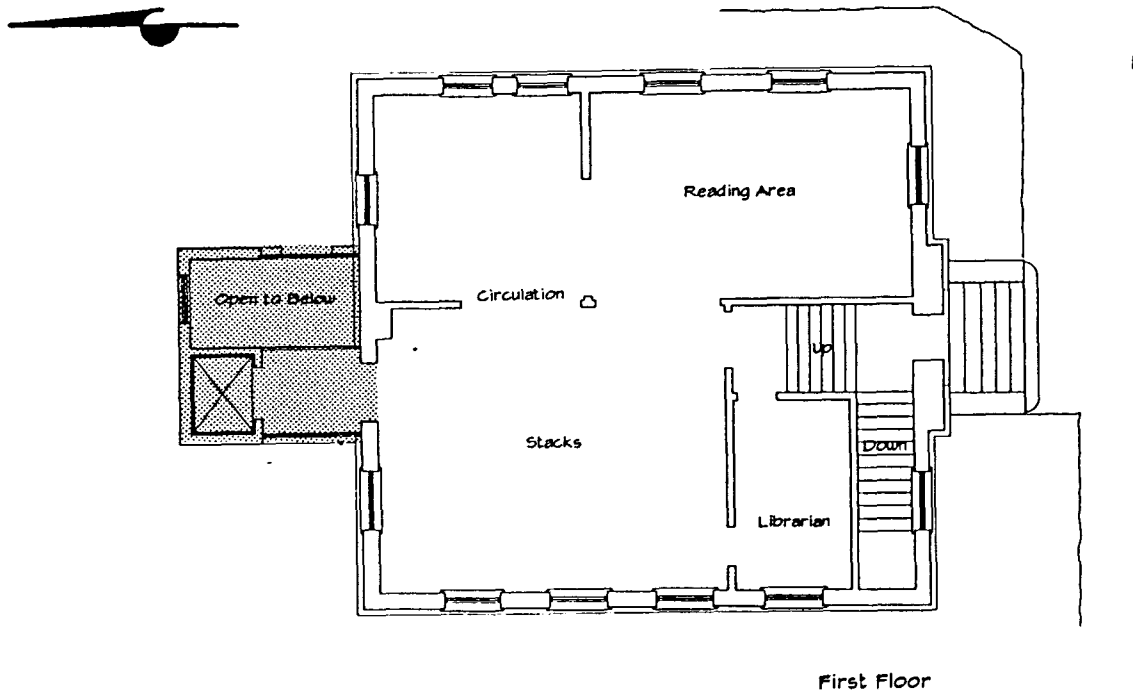
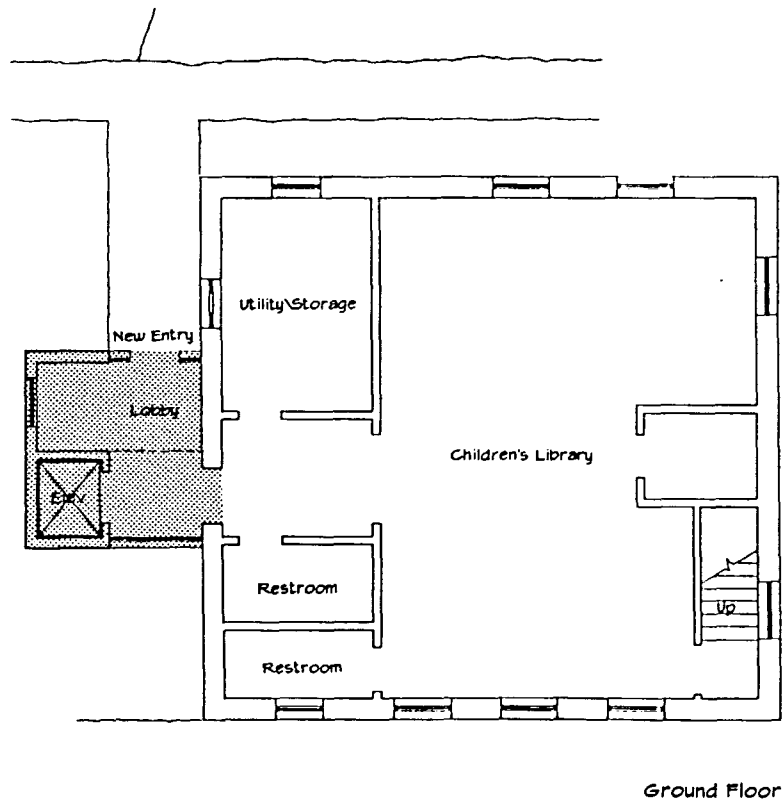
Figure 39. Proposed accessible entrance for Leon Public Library: Plan C

Option C (Figure 39) would create a new accessible, primary entrance. An addition, containing a new entry, lobby, and elevator, would be built at the rear of the building. This option would again preserve the existing street entrance. It would also leave the interior of the existing building virtually intact. All visitors may not share the same route or experience, but the quality of the experience of entry would be the same.

On the basis of the criteria set out above, Option C would be the preferred solution. It provides a quality experience of entry, free of stigma, to all the building's users. The intervention is clearly discernible, but without compromising the historic character or fabric of the existing building.
