Architectural ornamentation using
terra cotta: Evolution, use, and restoration
with emphasis on Louis Sullivan and
the Merchants National Bank

A Thesis Submitted to the
Graduate Faculty in Partial Fulfillment of the
Requirements for the Degree of
MASTER OF ARCHITECTURE

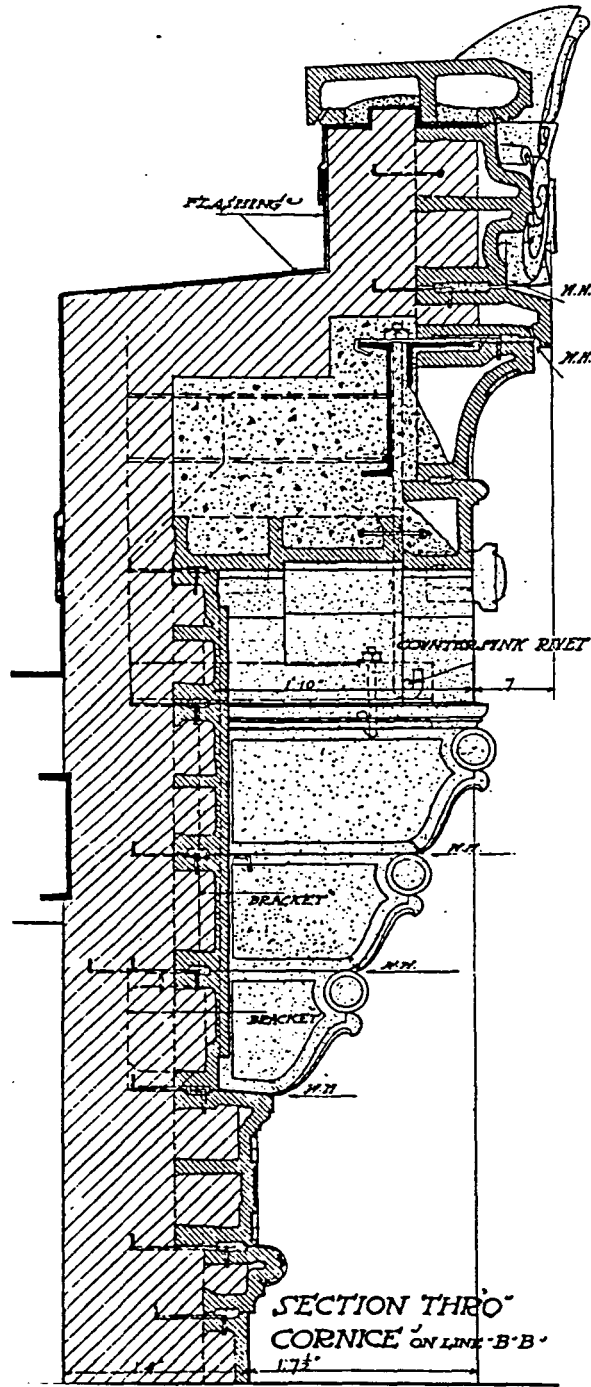
Figure 1. Section through Cornice
(National Terra Cotta Society, 1927, plate 24)

The architect and building owner must set priorities for the project. Whatever the decisions, the work must equal the spirit, attention to detail, (Fig. 1) and pride in craftsmanship associated with the original production of terra cotta. If inferior materials and workmanship are allowed, the building will suffer.

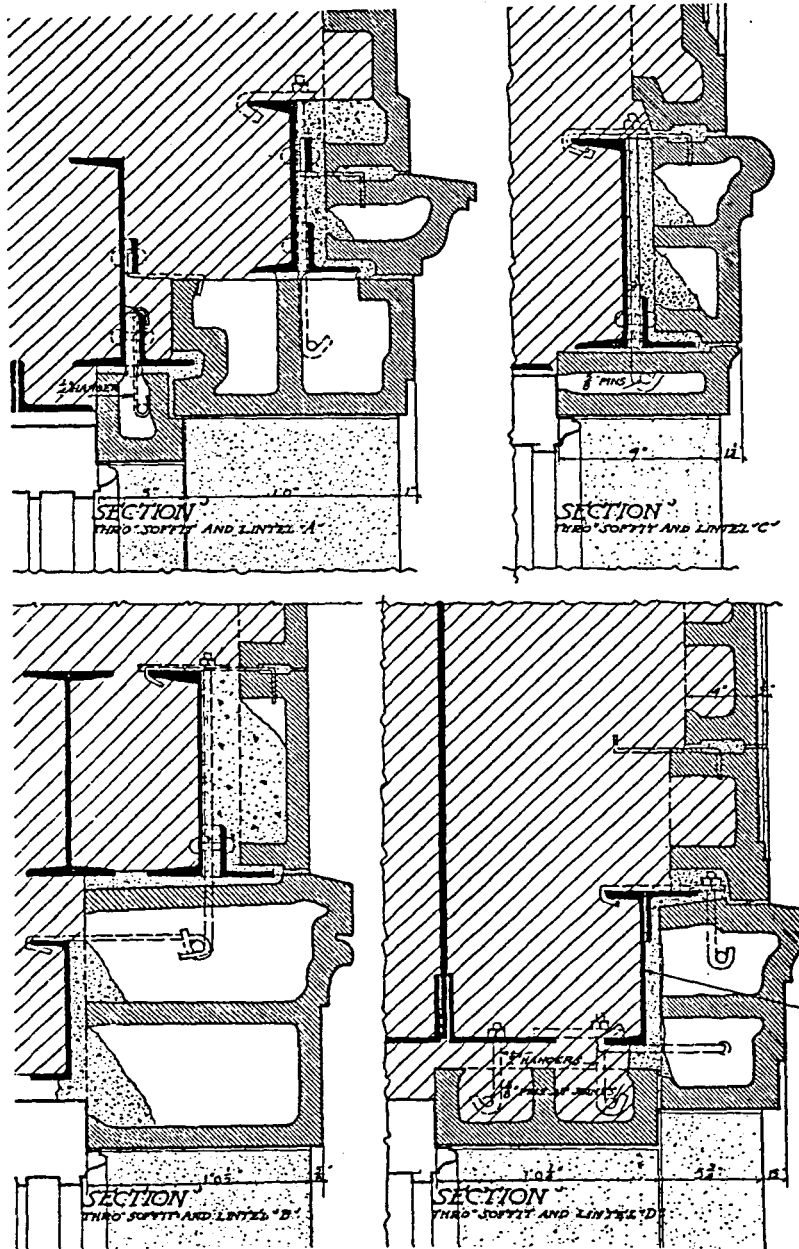
Figure 3. Lintels and Soffits
 (National Terra Cotta Society, 1927, plate 36)

The approach to terra cotta is a familiar one in preservation: if it ain't broke don't fix it (Tindall, 1987, p. 51). On the other hand, if units have failed, the first objective is to discover why they failed and if adjacent or similar units are about to fail. Where severe damage has caused structural problems, a structural engineer should be hired to analyze the condition of the steel anchoring system. Such structural deterioration must be stopped before any repair work can begin (Figs. 2 and 3).

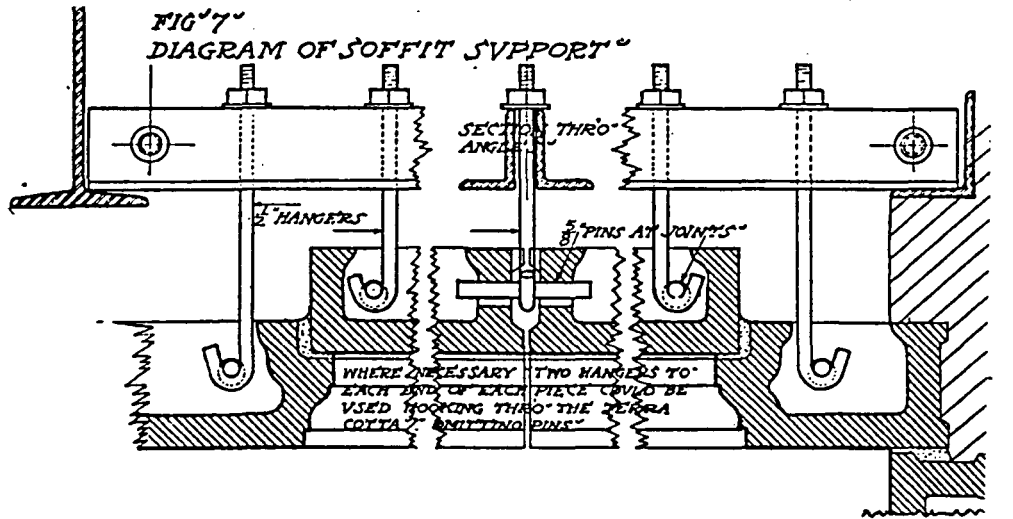
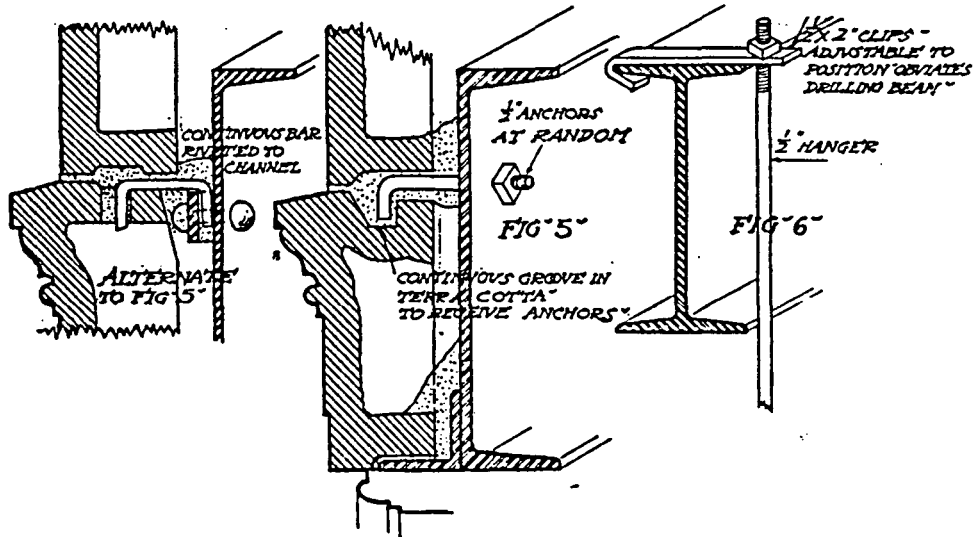
Figure 5. Anchor, Hanger, and Strap Details
(National Terra Cotta Society, 1927, plate 67)

When possible and where applicable, replacement units should be anchored in a manner similar to the original (Fig. 5). Both structural and visual compatibility are major considerations when choosing replacement materials.

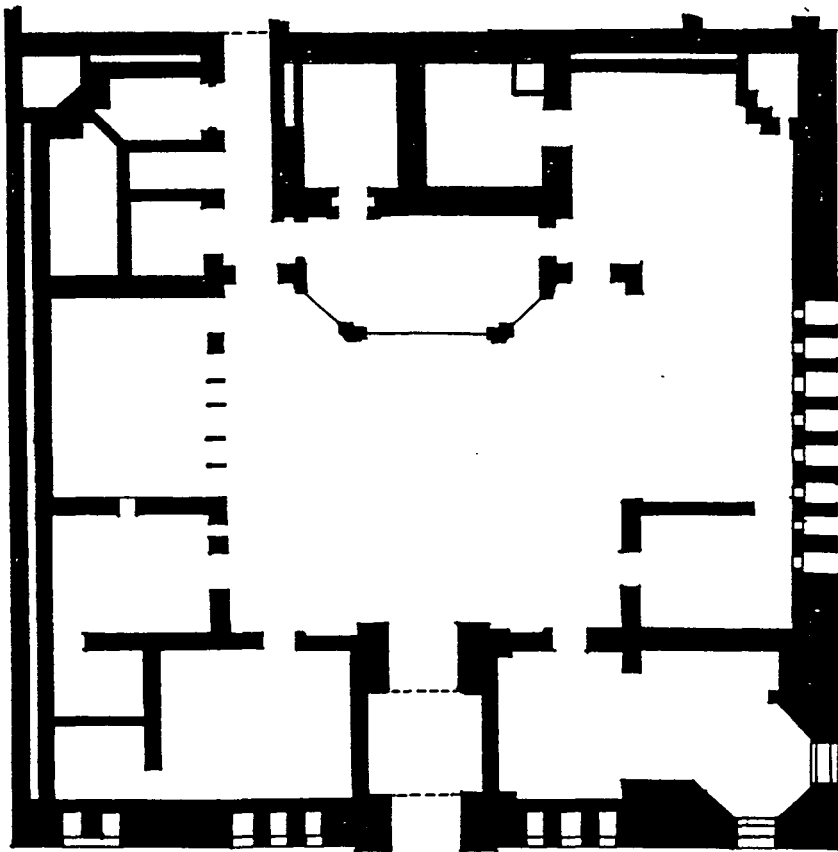
Figure 6. Farmers' National Bank, Floor Plan

The National Farmers' Bank (see Appendix A) and the Merchants National Bank (see Appendix B) both were designed around a "democratic" floor plan (Figs. 6 and 7). The plan can be called "democratic" in that it is open and the officers are in plain view and easily approached. This is the modern "human" element of the plan as it tends to promote a feeling of ease, confidence and friendship between officers, employees, and customers. The vault location was situated at the end of the room on direct axis with the bank's entrance. The large open door of the vault inspired confidence in the strength and security of the bank.

Sullivan used a basic floor plan in all his banks, making only minor changes as required by the program. In Grinnell, the bank is entered through a vestibule into a central public space.

On the left side were the special facilities: the women's room, a special room for women to do their banking, savings department and men's room. In the center of the bank was the vault and deposit boxes with a customers room and teller space in front. To the right of the public

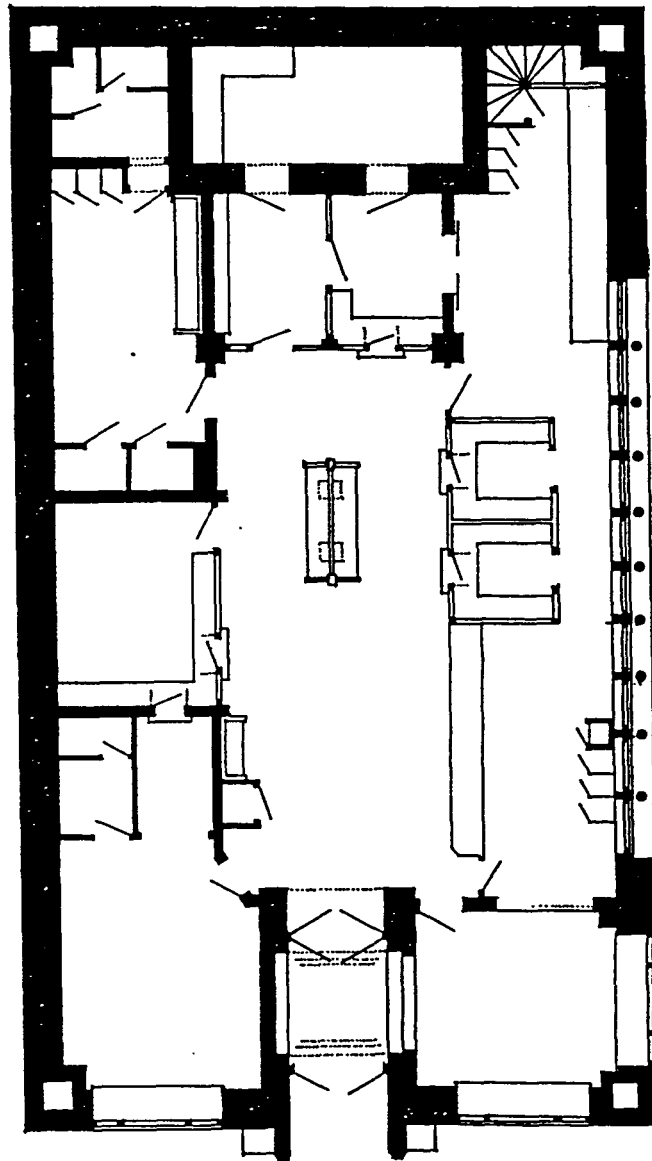
Figure 7. Merchants National Bank, Floor Plan

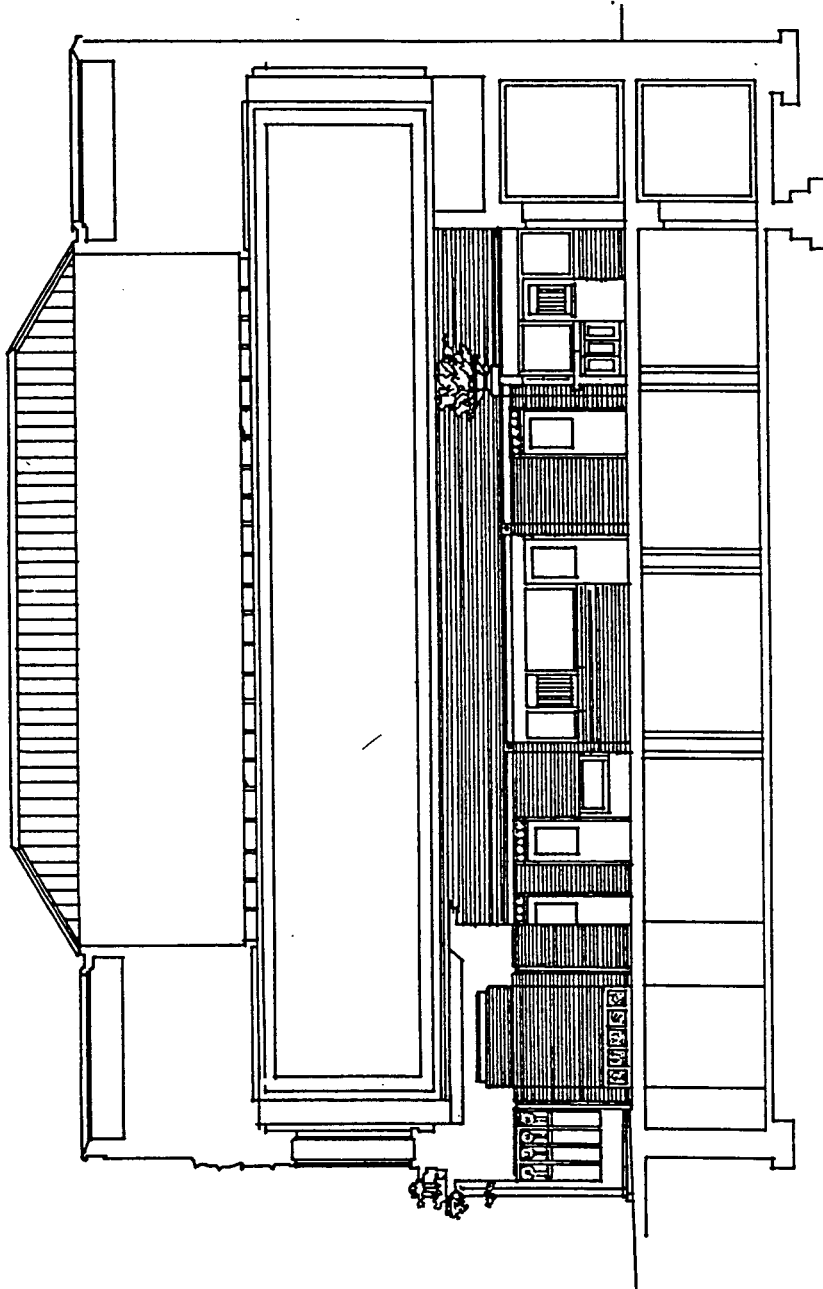
Figure 8. Merchants National Bank, Building Section

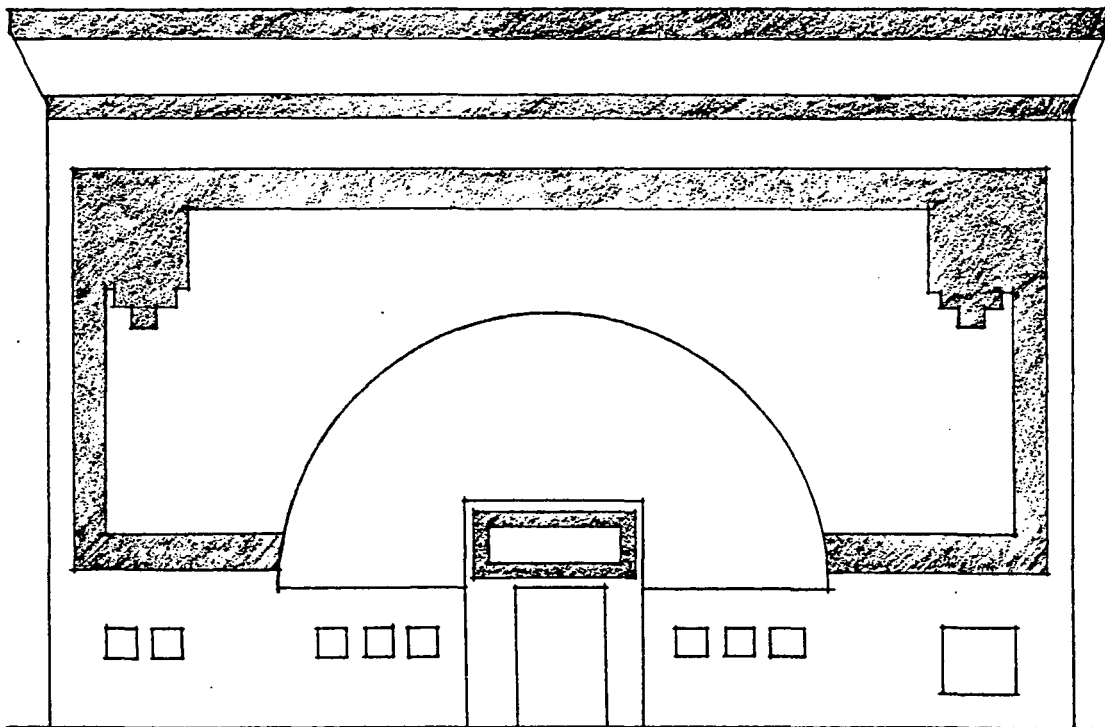
Figure 9. National Farmers' Bank. Relationship of terra cotta to building mass.

The exterior of the Owatonna bank is richly decorated. The facades are divided into three horizontal layers: a base of pink Portwing sandstone; a central layer of brick and terra cotta around a large, semi-circular window; and a brick and terra cotta cornice (de Wit, 1986, p. 180). Sullivan suggests an organic source that is making the building grow, while at the same time creating a tension between upward movement and downward pressure (Fig. 9). The sandstone base has small punched windows that suggest a solid, strong base, on top of which are the earth tones of the brick, the green terra cotta, and blue mosaic, which represent the colors of the surrounding framing community which supports the bank.

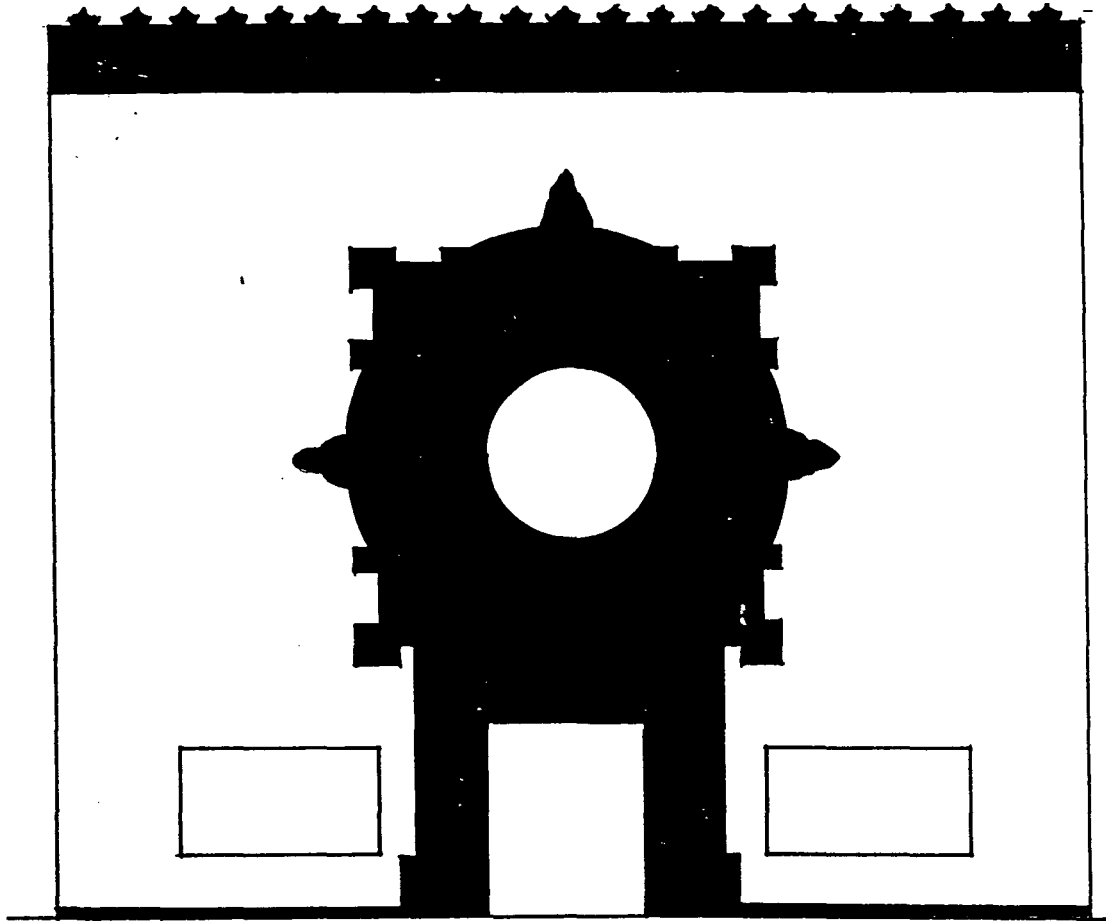
Figure 10. Merchants National Bank. Relationship of terra cotta to building mass.

The bank in Grinnell is a pristine brick box featuring a terra cotta frieze and a massive ornamented entrance (Fig. 10). The entrance ornament in the form of superimposed circles, squares, and diamonds surrounds a large circular window; such a synthesis between geometry and natural forms is the essence of Sullivan's objective - subjective symbolism of ornament and architecture.

The long brick east wall has two openings, both are cut sharply into the surface, a large window above the tellers, and a small window in the directors room. The plainness of the exterior at Grinnell is contrasted with the elaborate ornament placed at the entrance and the cornice line.

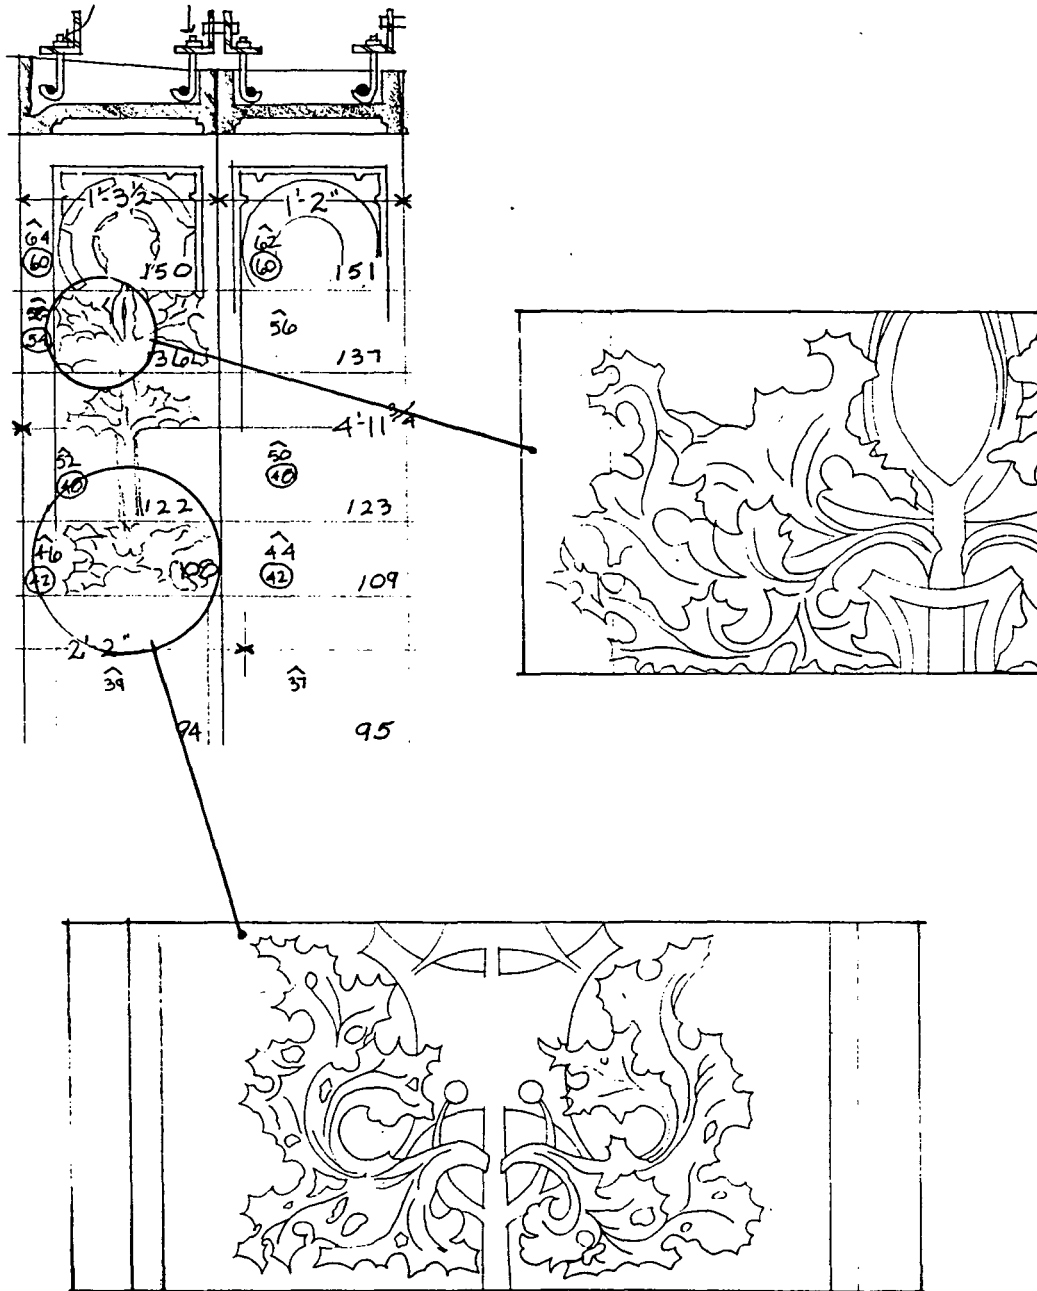
Figure 12. Terra cotta piece sketches

At the initial stages of the project, careful measurements were made of the existing piece. Since no pieces were available to be removed from the building, measurements, field sketches, notes, and photographs were made (Fig. 12). Also the discovery of the original terra

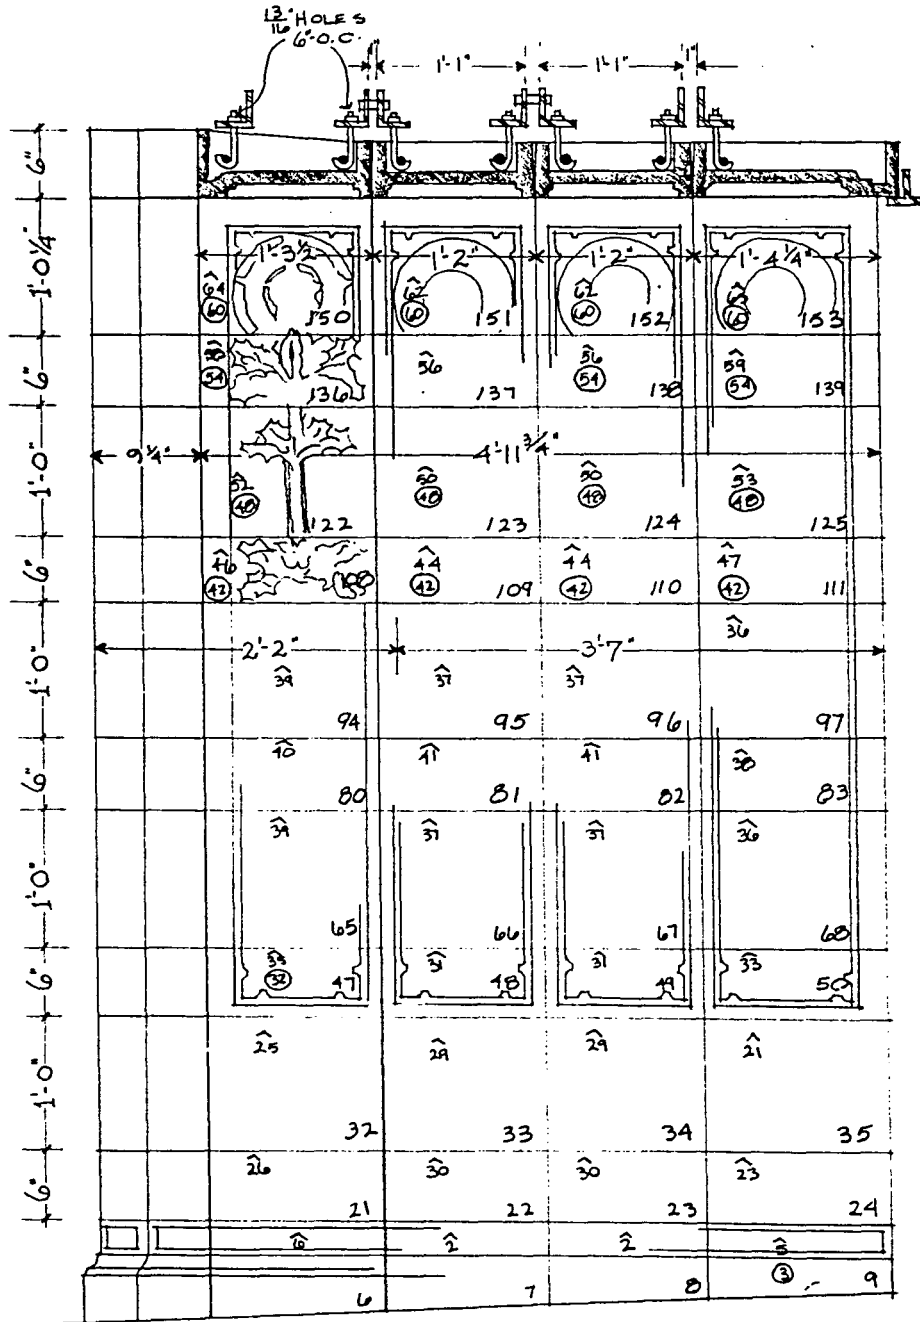
Figure 13. Original terra cotta setting drawings

cotta setting drawings aided in obtaining exact measurements (Fig. 13 and 14).

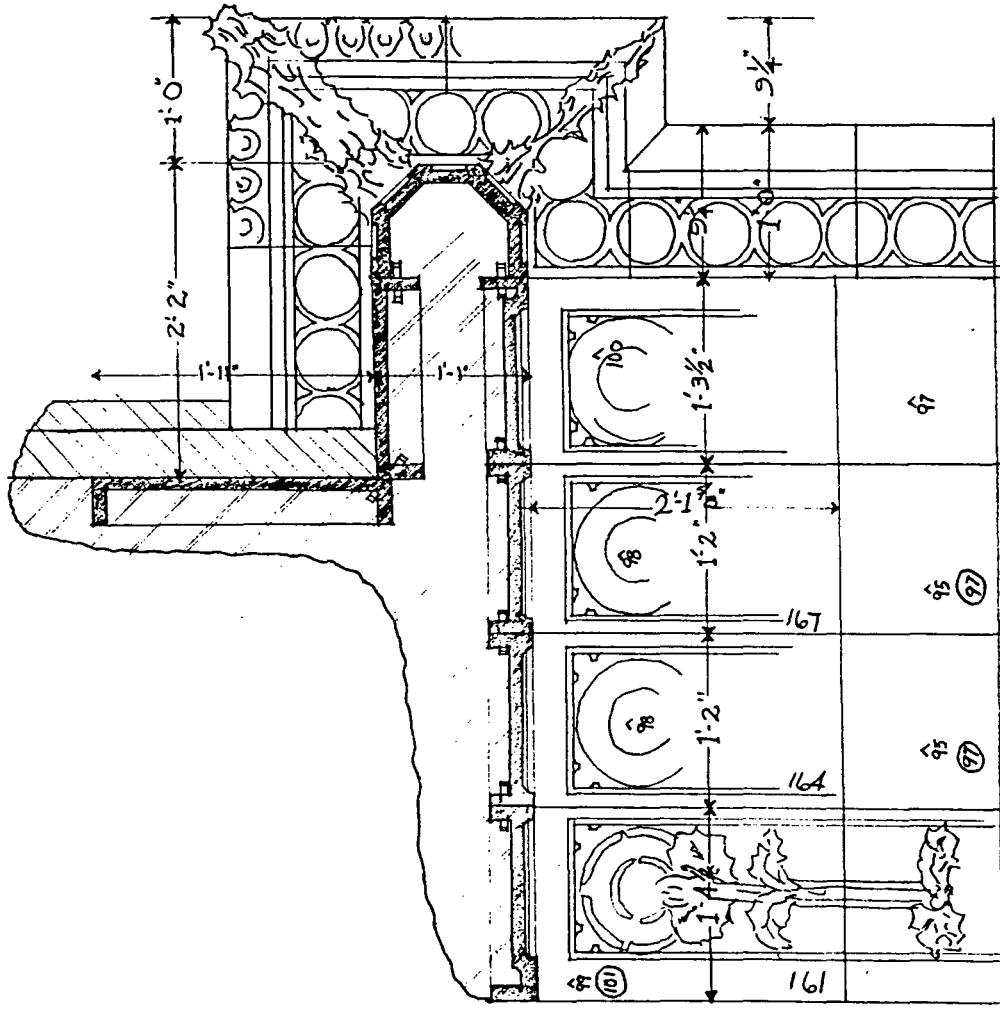
Figure 14. Original terra cotta setting drawings

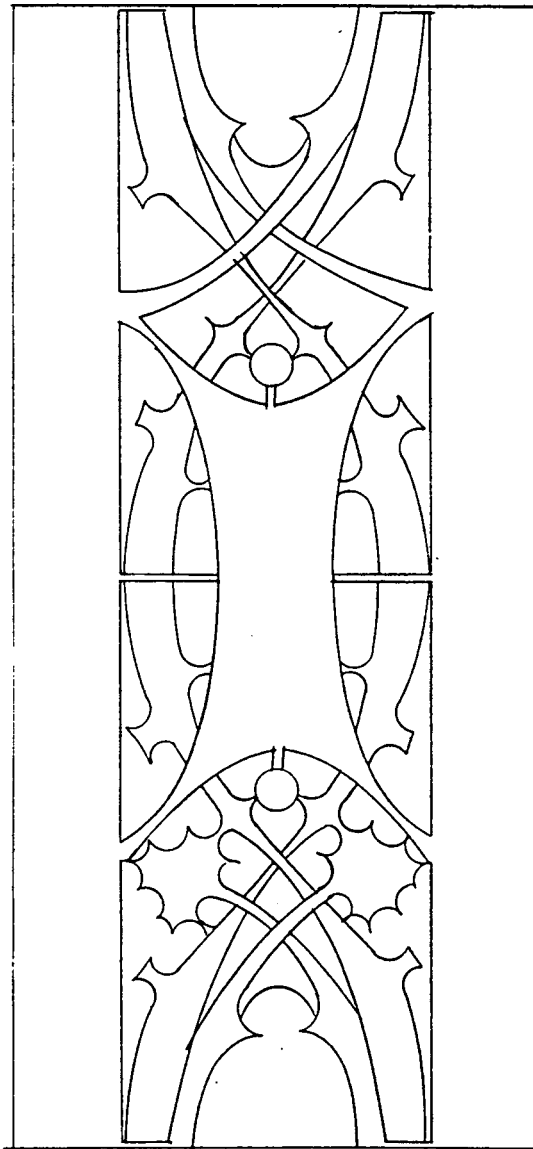
Figure 15. Terra cotta piece templates

To aid in making the original model, I transferred all scale drawings to chipboard. The chipboard became a template (Figs. 15 and 16) with which I transferred the design to the clay.

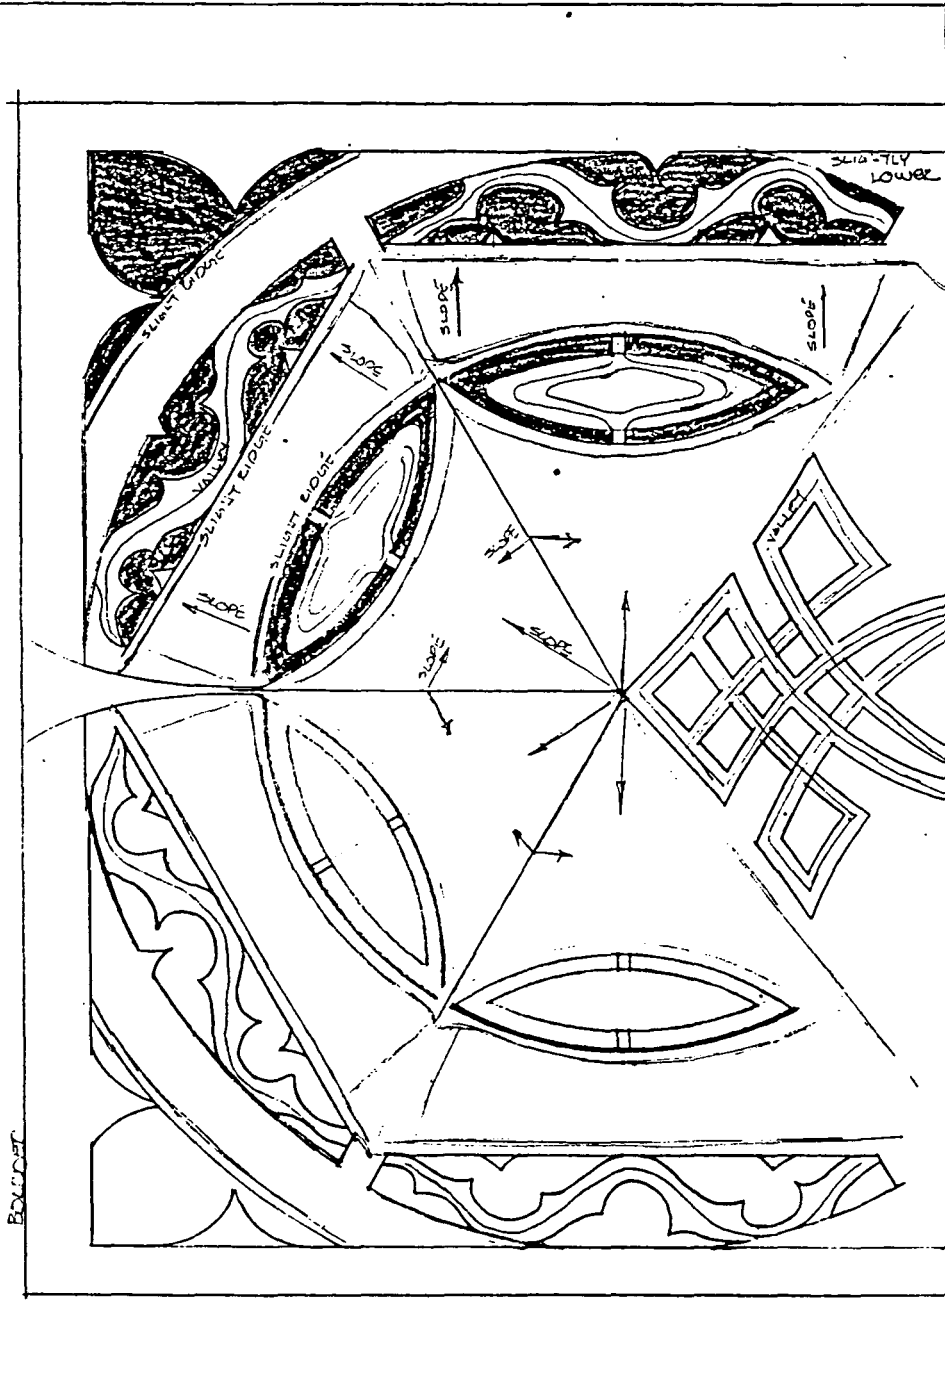
Figure 16. Terra cotta piece templates

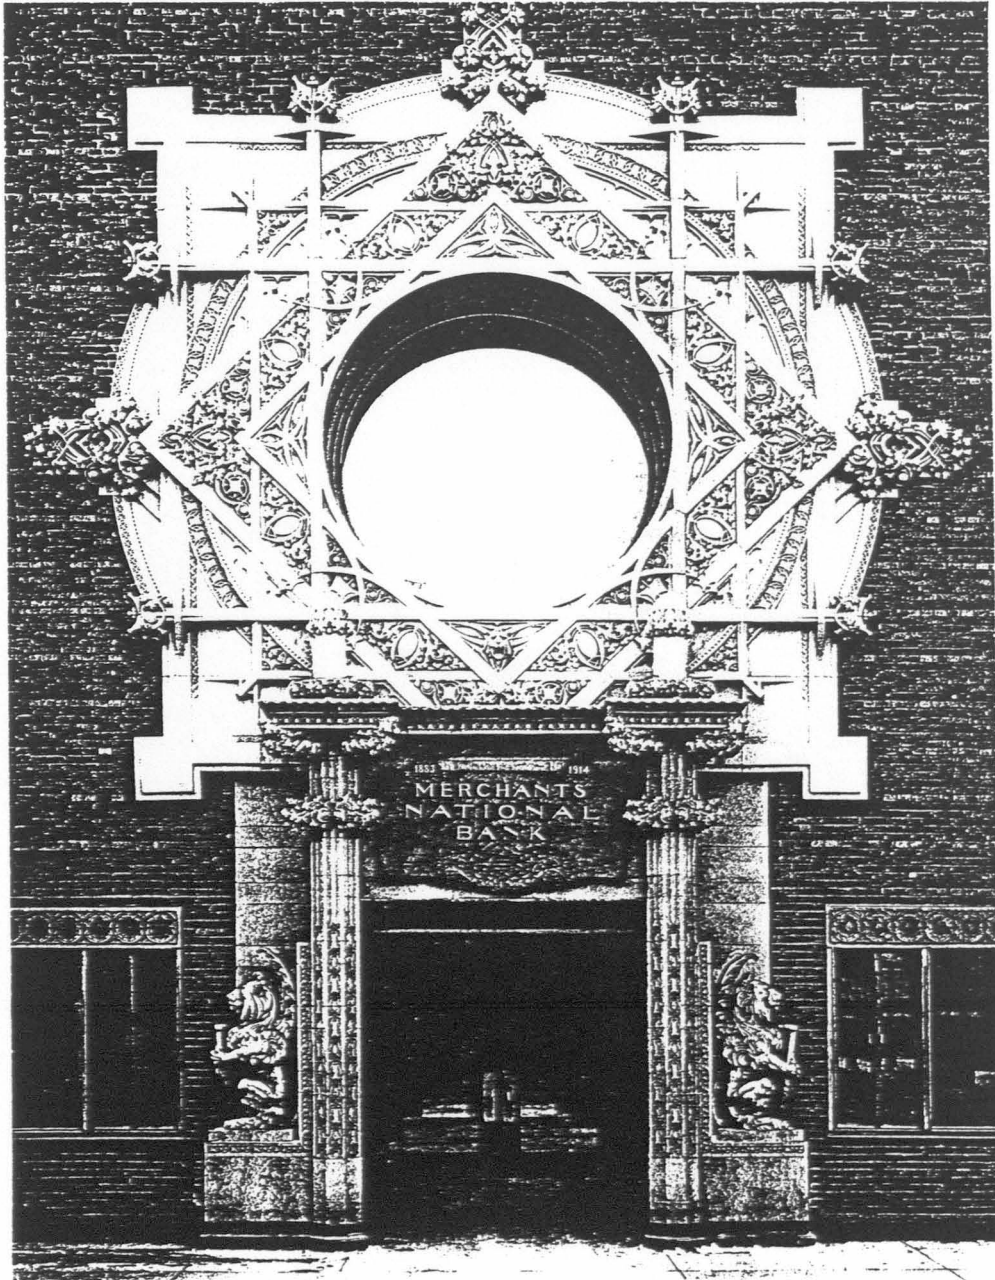
Figure 20. Merchants National Bank. Detail of Entrance.
Photo: Henry Fuermann, Chicago Architectural
Photographing Co.

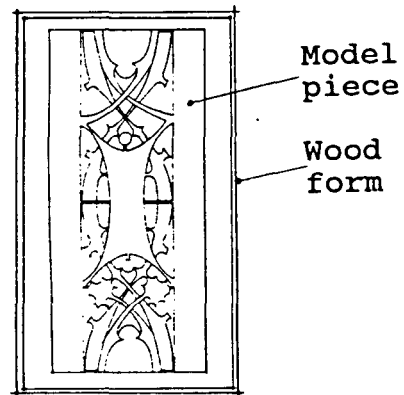
STEP 4)

I then made a wooden form work, slightly larger than the modeled piece, in which to set the model. Plaster of paris is poured covering the piece to a depth of 1". The modeled piece is then removed, and the finished mold is cleaned.

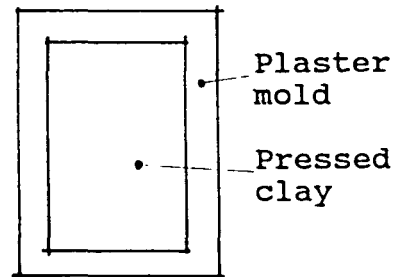
STEP 5)

The clay is then pressed into the molds. The clay is left in the molds until it stiffens, usually a few hours. When the clay can support its own weight the mold is removed.

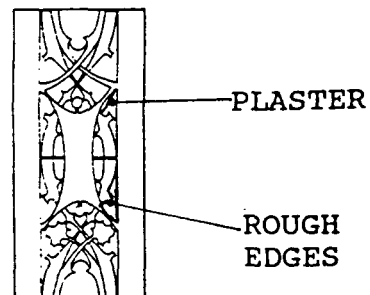
STEP 6)

The cast is then finished to remove imperfections and add detail. This is done with various ceramic tools and smoothing the piece with pieces of wood and sponge.

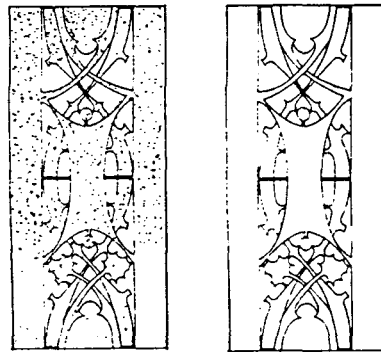
STEP 7)

After the piece is finished, it is allowed to dry. Placing the piece in the kiln room caused a quicker and better drying.

Wet Piece Dry Piece
(lighter color)
